Rail Accident Report

Head-on collision between a passenger train and a freight train  
in Tempi, 28 February 2023

RL01-2025, 27 February 2025

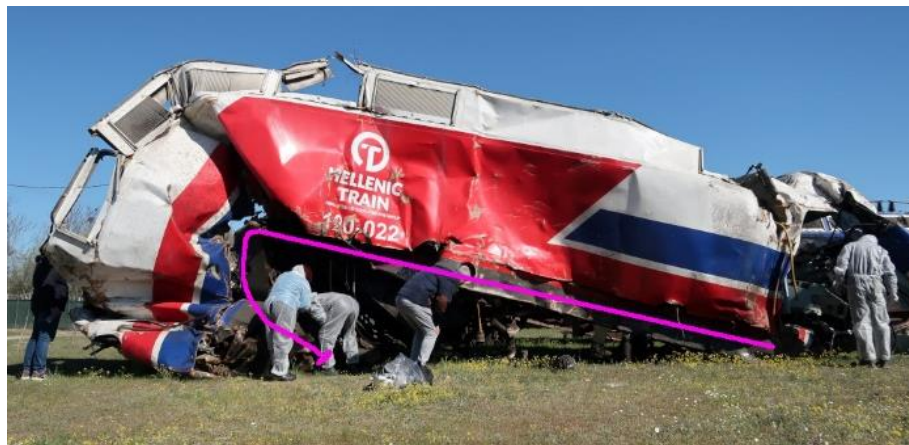
Figure 14. The first locomotive of the freight train (120-022) showing extreme damage from the very heavy head-on collision with the locomotive (120-023) of the passenger train.

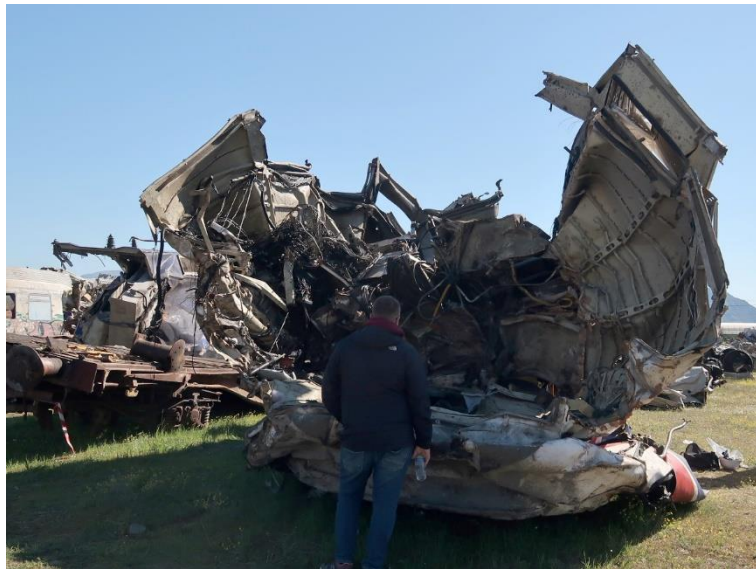
Figure 16. Front view of the locomotive 120-022, roof missing.

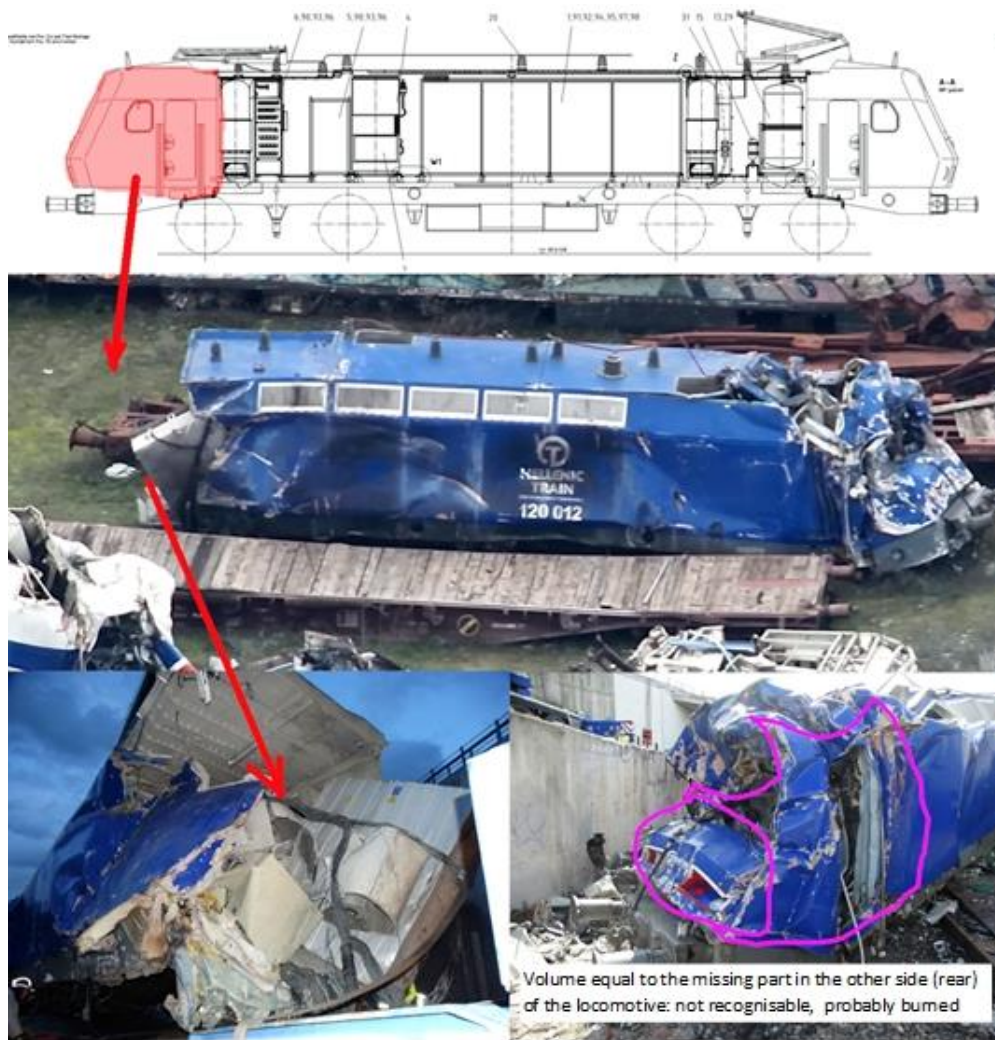
- 136 The rear driver's cabin of the 120-012 locomotive appears to be cut off from the rest of the vehicle and it cannot be completely identified anywhere among the debris, apart from a small part of its roof and top headlight (in front of the first container). The rest of the cabin cannot be identified as a whole and also the front panel with the painted number and the two red headlights are also not recognisable among the debris. Presumably, the missing structure is among the crashed and burned remains of the Restaurant Car, as this is the only place in the whole accident site where the fire burned so fiercely that it totally consumed the heavy industrial-grade paint of the blue locomotive, making it unidentifiable.

Figure 20. Missing rear-end of the locomotive 120-012.

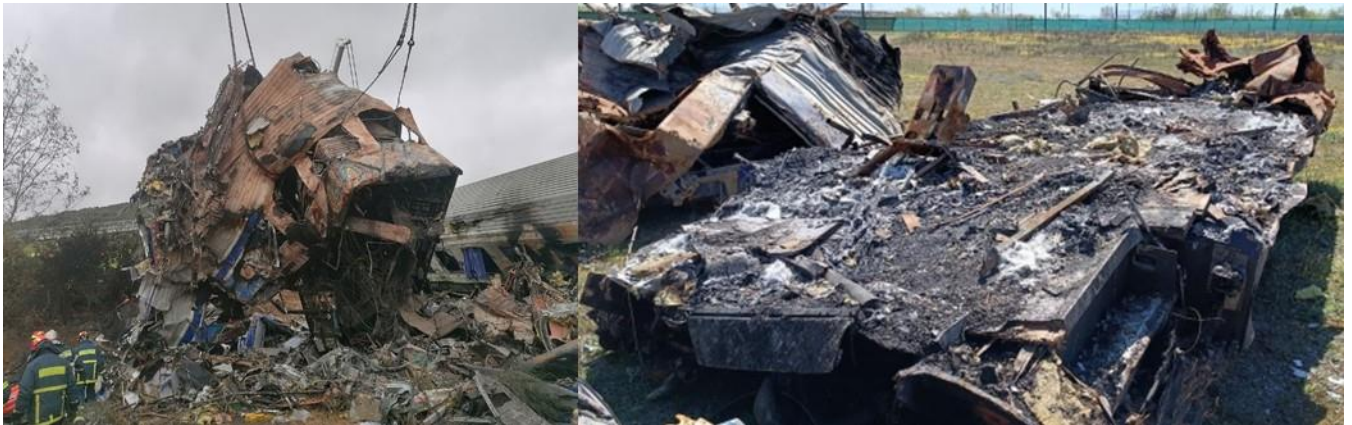
- 137 This second collision causes very heavy damage to the Restaurant Car (Figure 21) that is bent into an S-shape mostly due to this initial impact but also sustaining damage while rolling and hitting the ground on its way to the lower verge, to end almost on top of the remains of the locomotive 120-023 and the destroyed A1 first-class coach.

Figure 21. Remains of the Restaurant Car, on the left, S-shaped as found on-site, and on the right, its platform at Koulouri site.

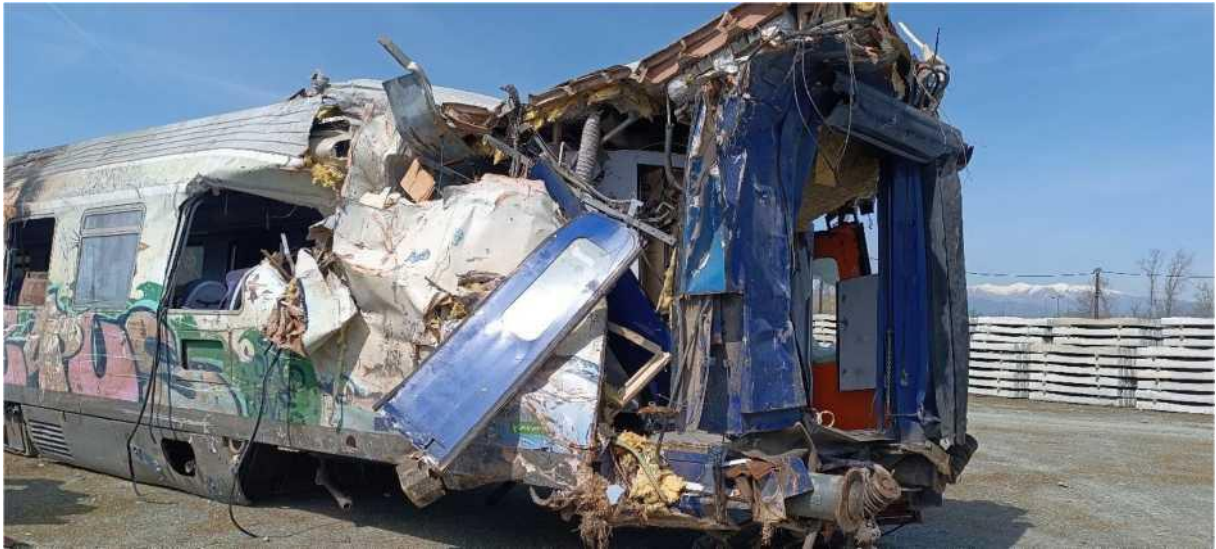
140 Derailed by the collision of the Restaurant Car, the B2 vehicle (a passenger coach divided into 11 6-seat compartments) continues straight ahead with a slight angle to the train tracks, nose diving downwards and hitting the ground with its front end, bending and breaking off its front section in the middle of compartment no 2. After the head-on impact, the rear of the wagon is lifted high and to the left and coming down to hit the front of the B3 passenger coach.

*Figure 23. Remains of the B2 coach*

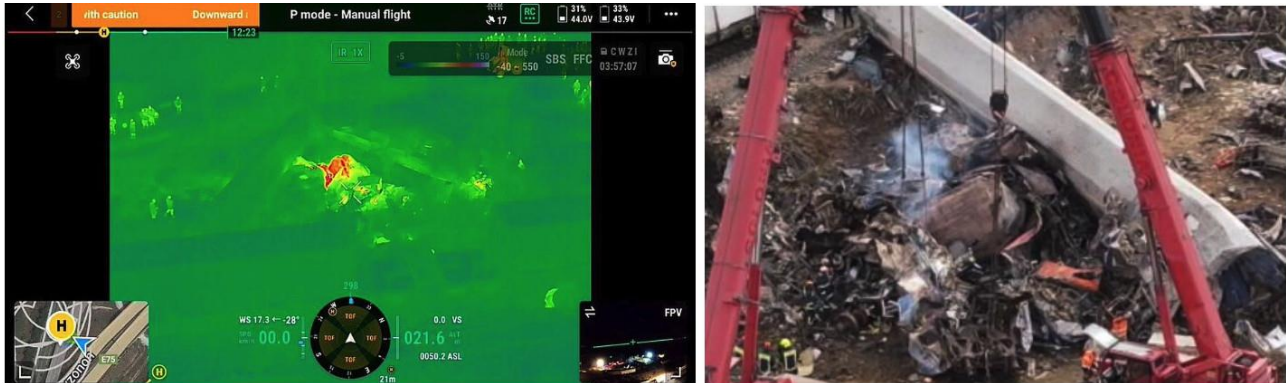
Figure 32. Fire simmering inside the Restaurant Car for 12 hours.

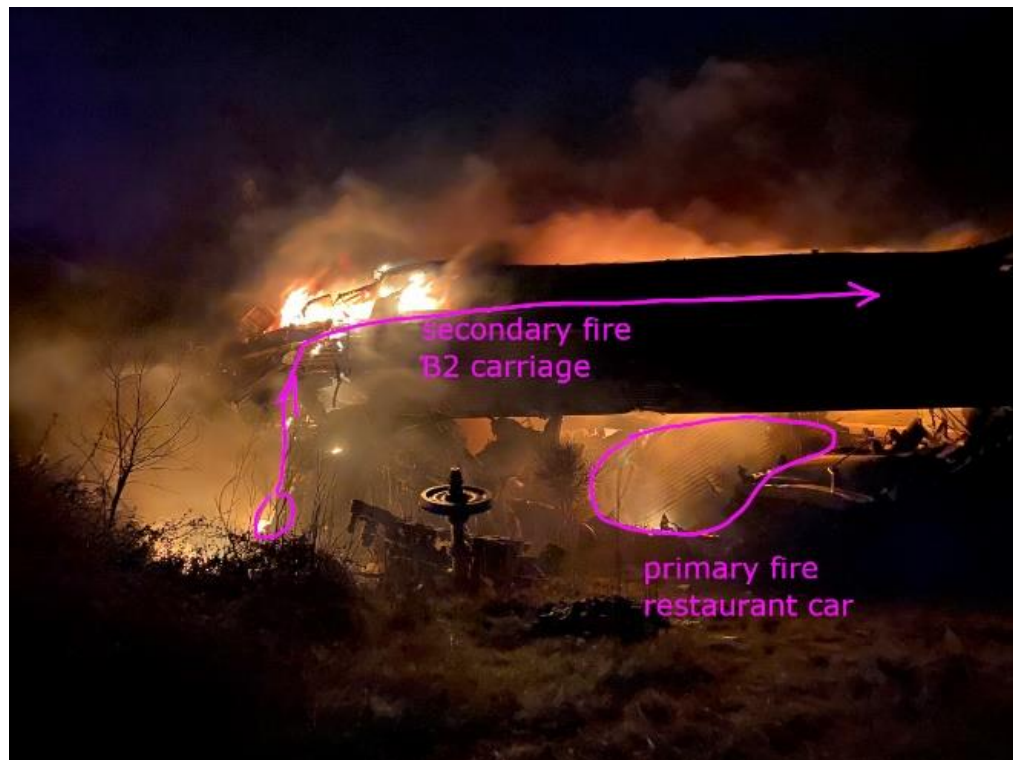
Figure 33. Another fire started at the front of the B2 coach.

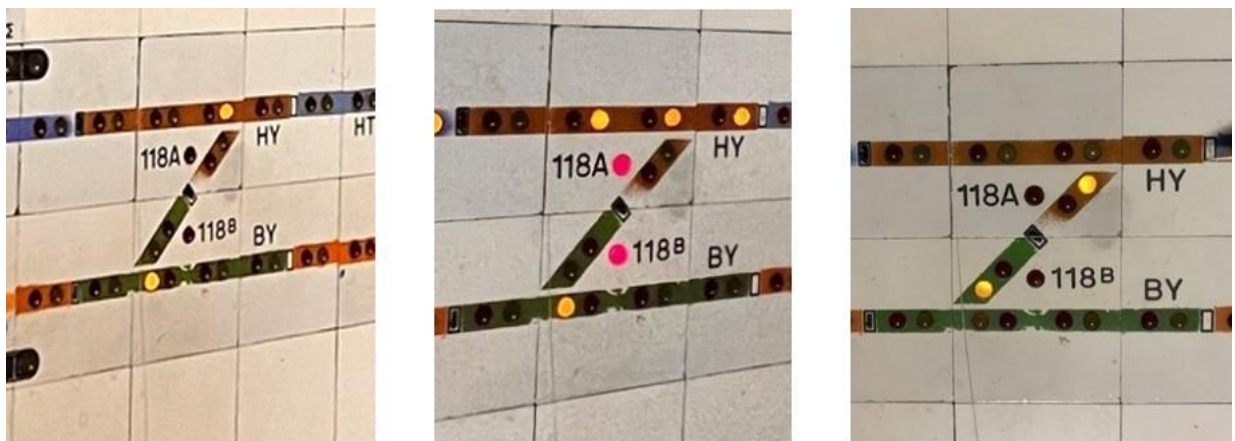
Figure 47. Detail of the switches 118 on the Larissa Control Panel (main-moving-bypass).

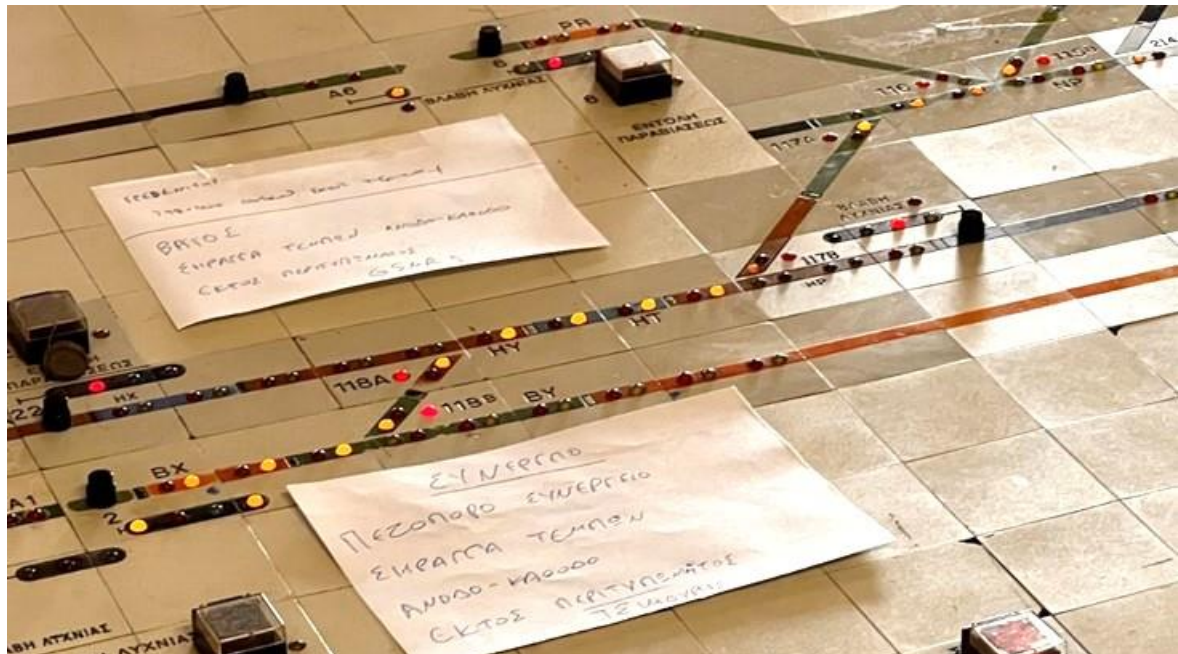
Figure 48. Detail of the Larissa Control Panel with a route set to cross a switch in a bypass position.

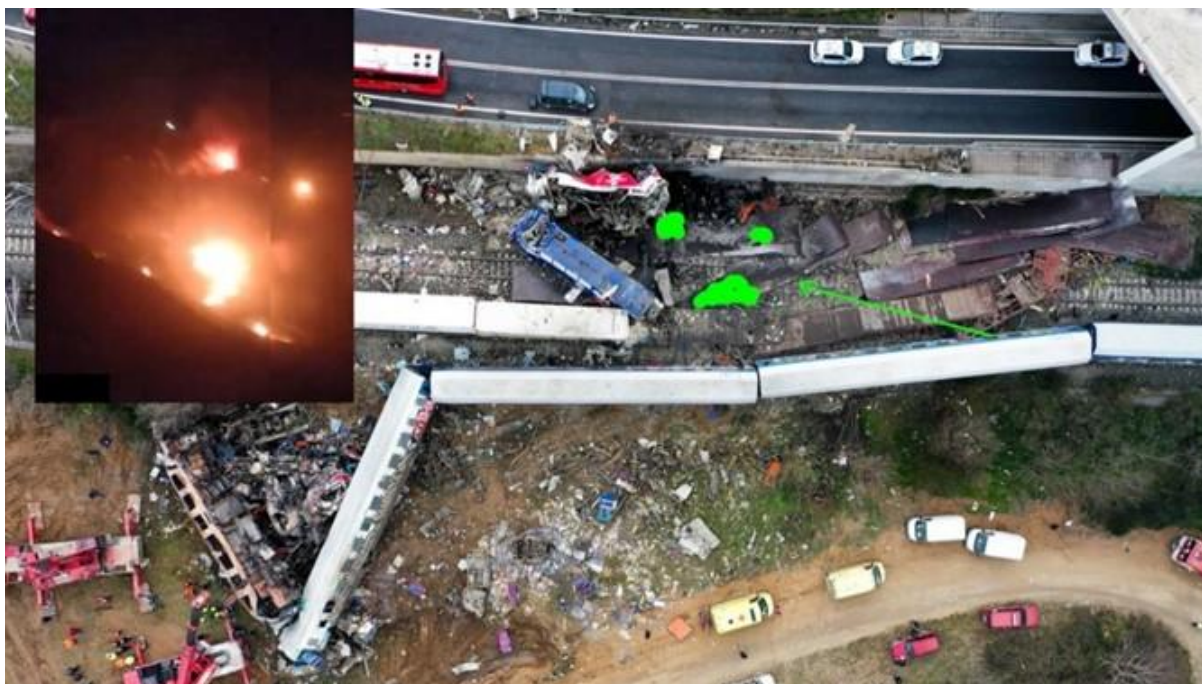
*Figure 64. Fire inside the transformer of freight train as a secondary result of pool fire #1.*

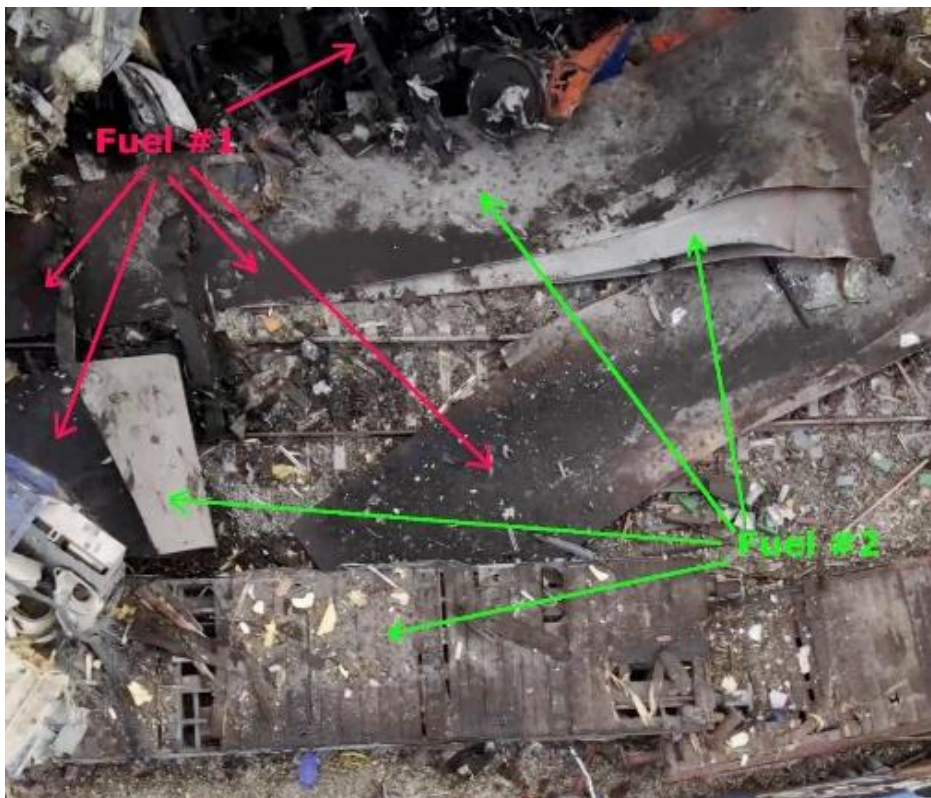
Figure 66. Evidence of two different fuels burning in the pool fire #1, one leaving black, the other leaving white residue.

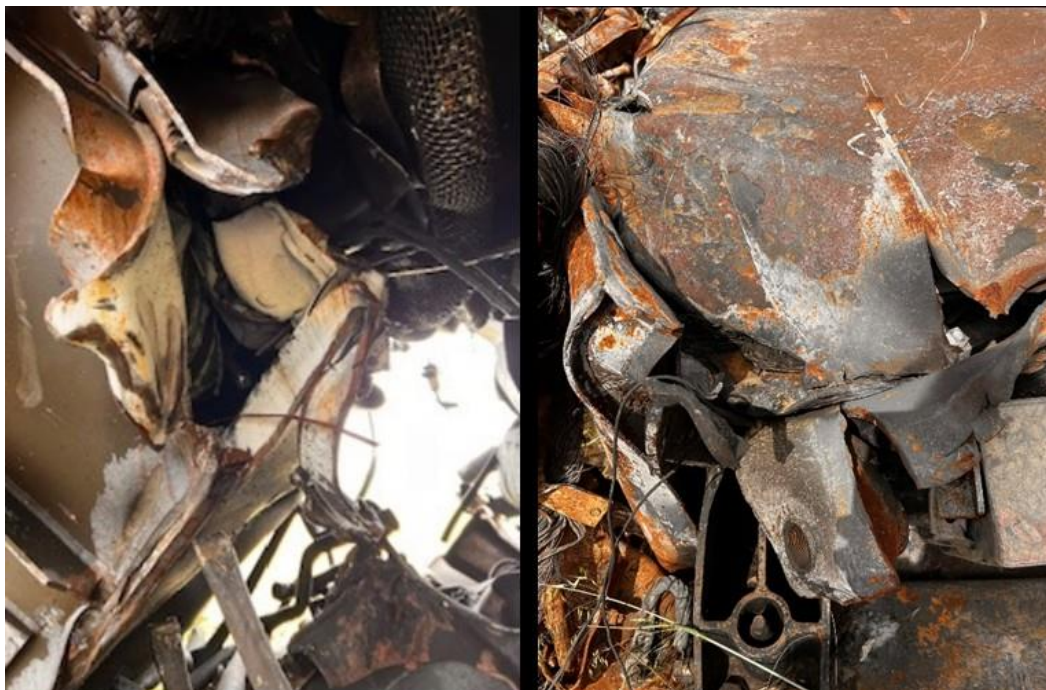
Figure 67. Large cracks of the transformer still attached under the 120-022 locomotive (Left). Bumps, folds, rips and large cracks of remaining locomotive transformer 120-023 (right), see also Figure 61.

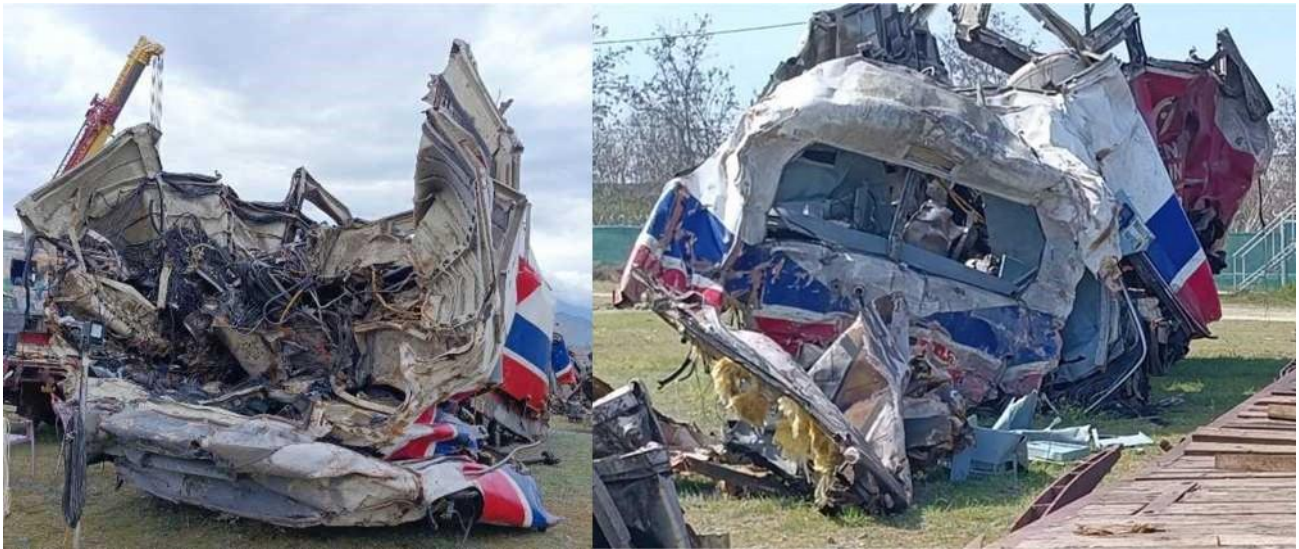
Figure 77. Position 1) Siemens Hellas Sprinter 120-022- NVR Engine: 91 73 212 0 022-7 Extreme damage on the front, roof missing, and rear heavily damaged from the rear collision with the attached locomotive 120-012. Rear view in Figure 14.

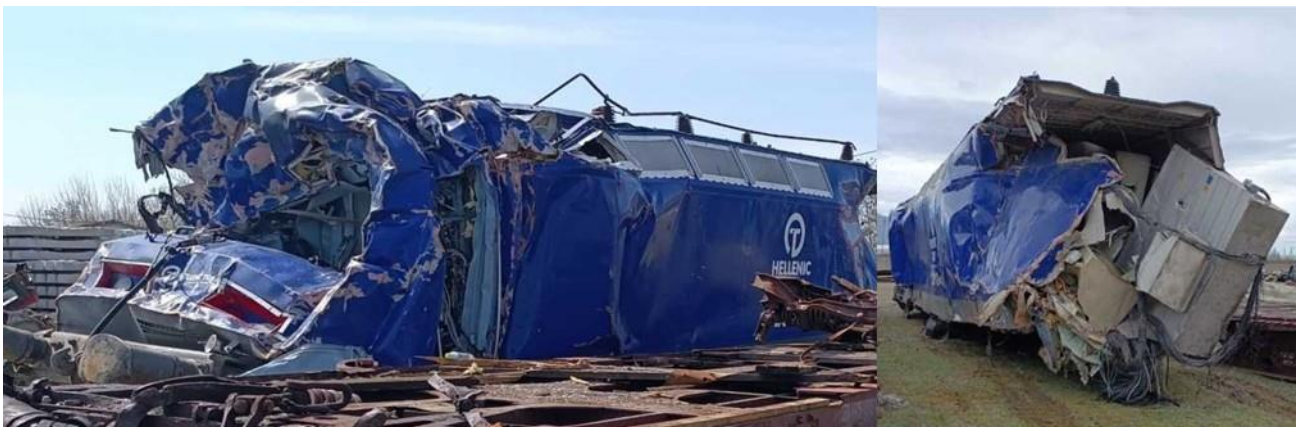
Figure 78. Position 2) 120 012 locomotive, heavy damage in the front (with locomotive 120-022) and rear, signs of crash against 1st container on P4, without the missing rear cab.

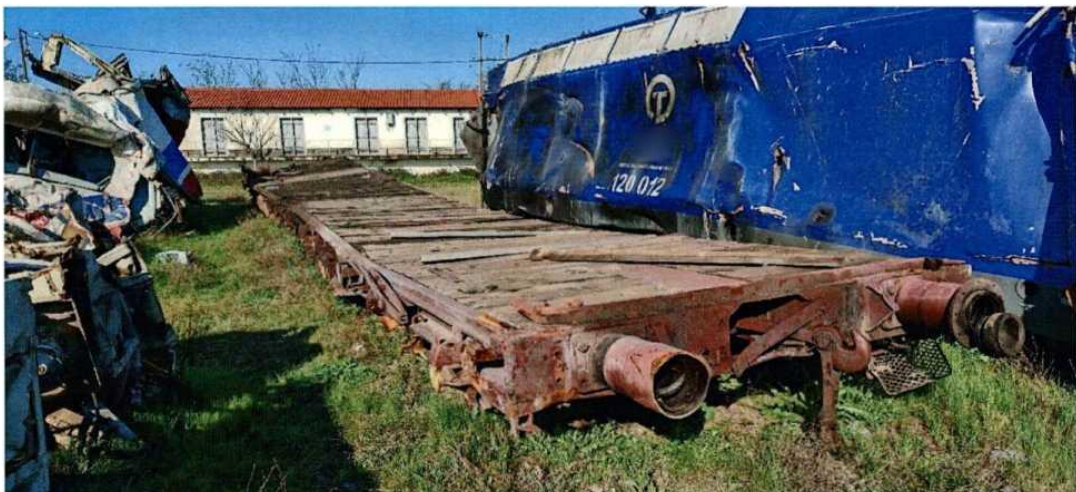
Figure 81. Position 5) nr 3 platform carrying steel plates, lost bogies from derailment, slight damage (twist) due to crash from the rear.

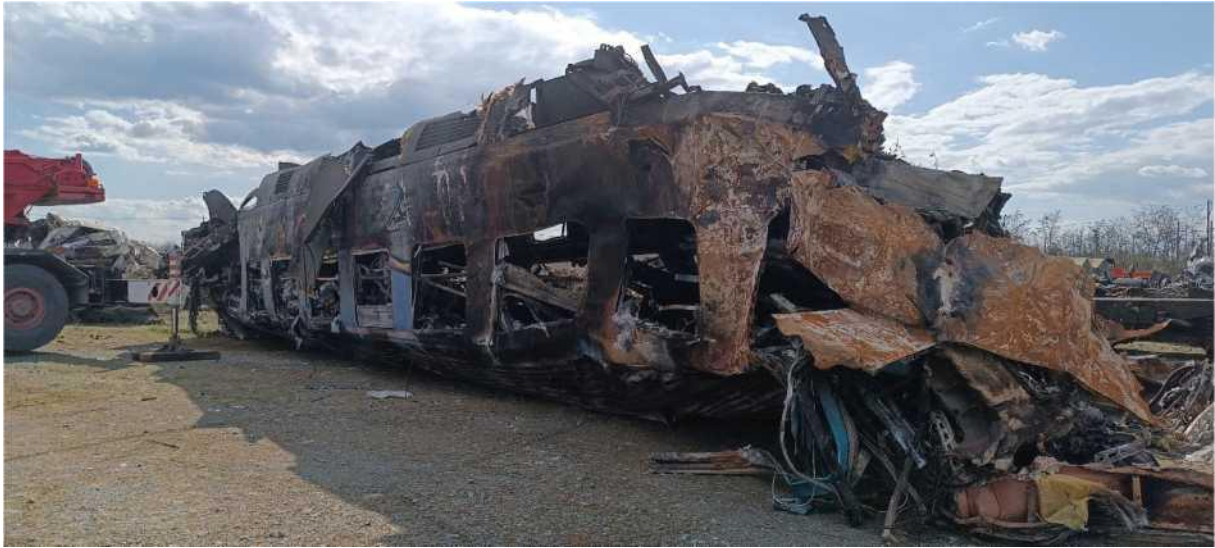
*Figure 87. Position 4) B2 2nd class coach, heavy impact damage in the front and rear, fire slowly consumed it.*

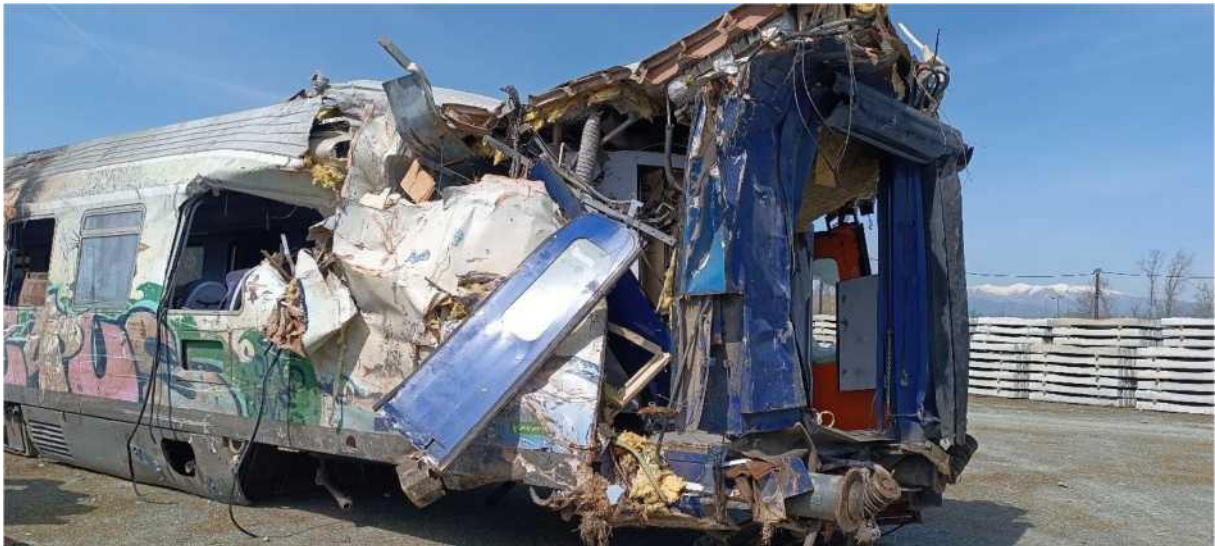
*Figure 88. Position 5) B3 2nd class coach, derailed and went down a slope, lost bogies, no other damage from derailment or crash, specific impact damage from B2 coming down from above.*

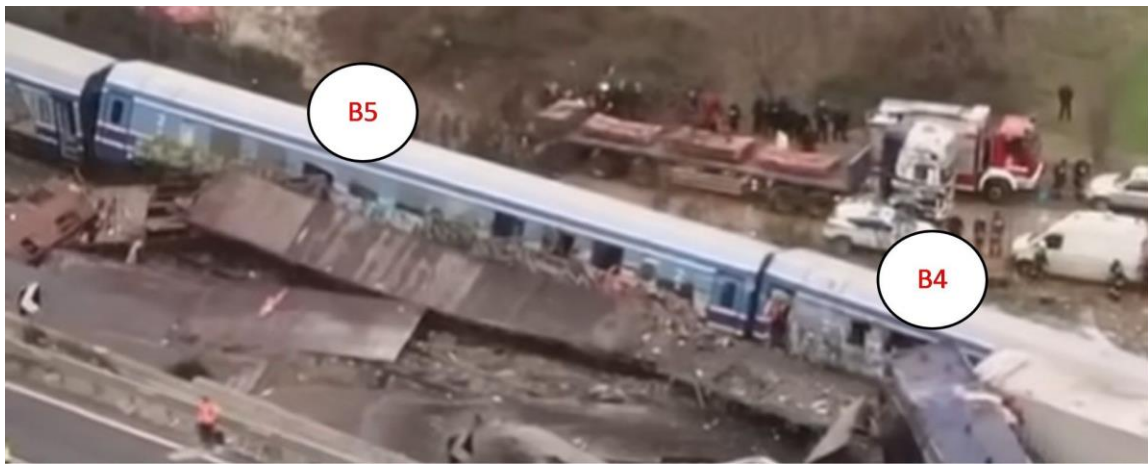
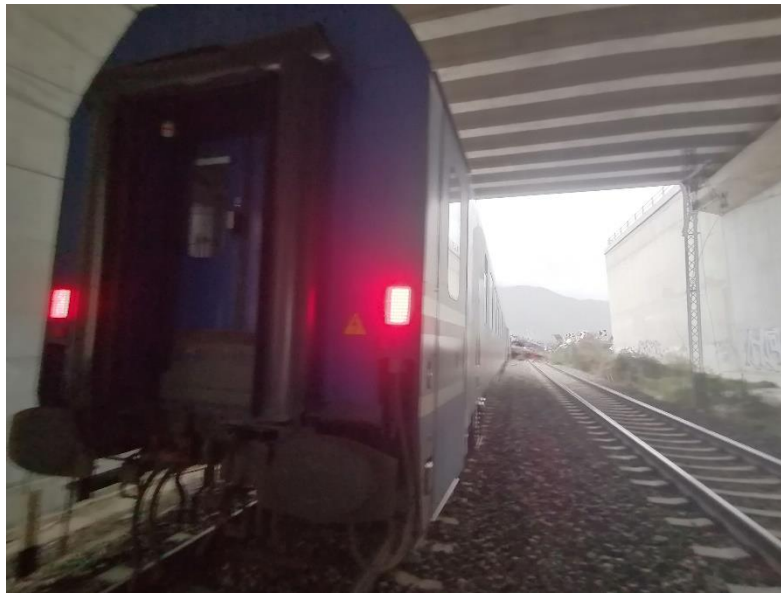
*Figure 89. Positions 6-9) B4-B7 coaches, B4 and B5 derailed and were hit on the side by steel plates, B6 and B7 did not derail, no damage, B7 remained nearly all in the tunnel.*
