Rail Accident Report

Head-on collision between a passenger train and a freight train  
in Tempi, 28 February 2023

RL01-2025, 27 February 2025

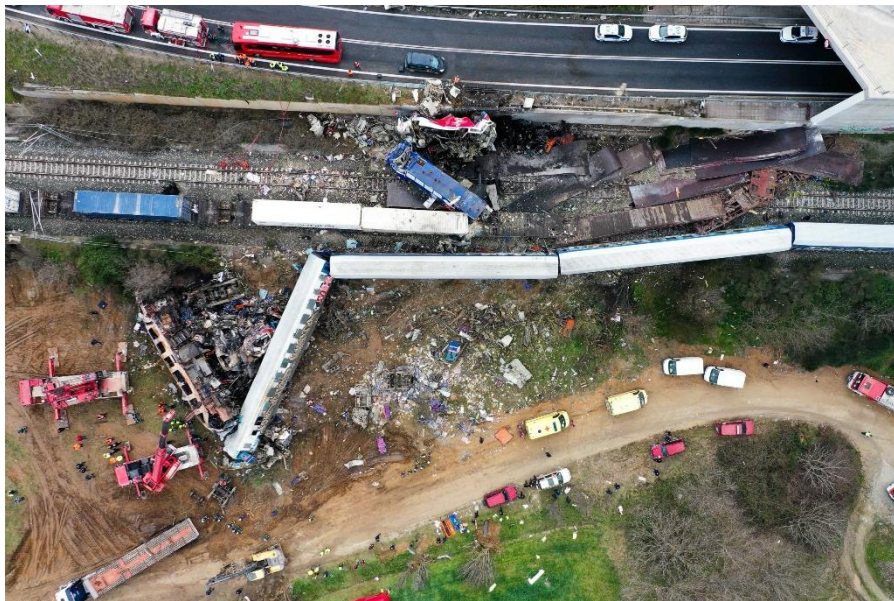
Figure 10. The end position of the 3 locomotives and some of the passengers coaches and freight wagons (<http://www.intime.gr/>).

- 130 The 1st phase mainly involved the first 4 vehicles of the two trains: 2 locomotives 120-022 (first) and 120-012 (second) of the freight train and the locomotive 120-023 with its first-class A1 coach. The initial impact is a head-on collision between passenger train locomotive 120-023 and the first freight train locomotive 120-022, that causes the latter, along with the second locomotive 120-012 to be catapulted towards their left over the upward line track and smashed against the motorway wall, with the second locomotive making a U-turn and its rear end sliding over the steel plates carried on the 3rd platform of the freight train to come to a standstill with its front side against the first locomotive and its rear end resting against the first shipping container carried on top of the 4<sup>th</sup> platform of the freight train (Figure 10, Figure 11, Figure 12).

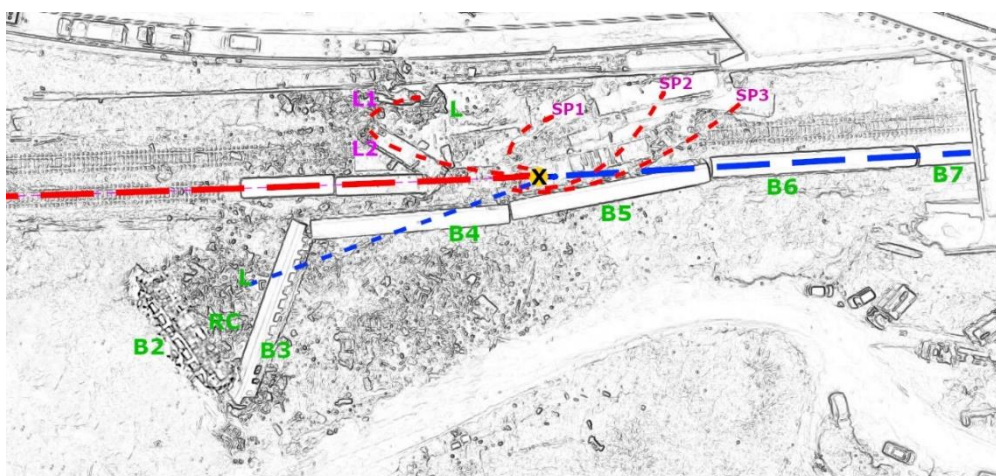
Figure 11. Global movement of the collision, with the initial impact and catapult effects.  
(SP1,2,3 are Steel Plates, and were also catapulted)

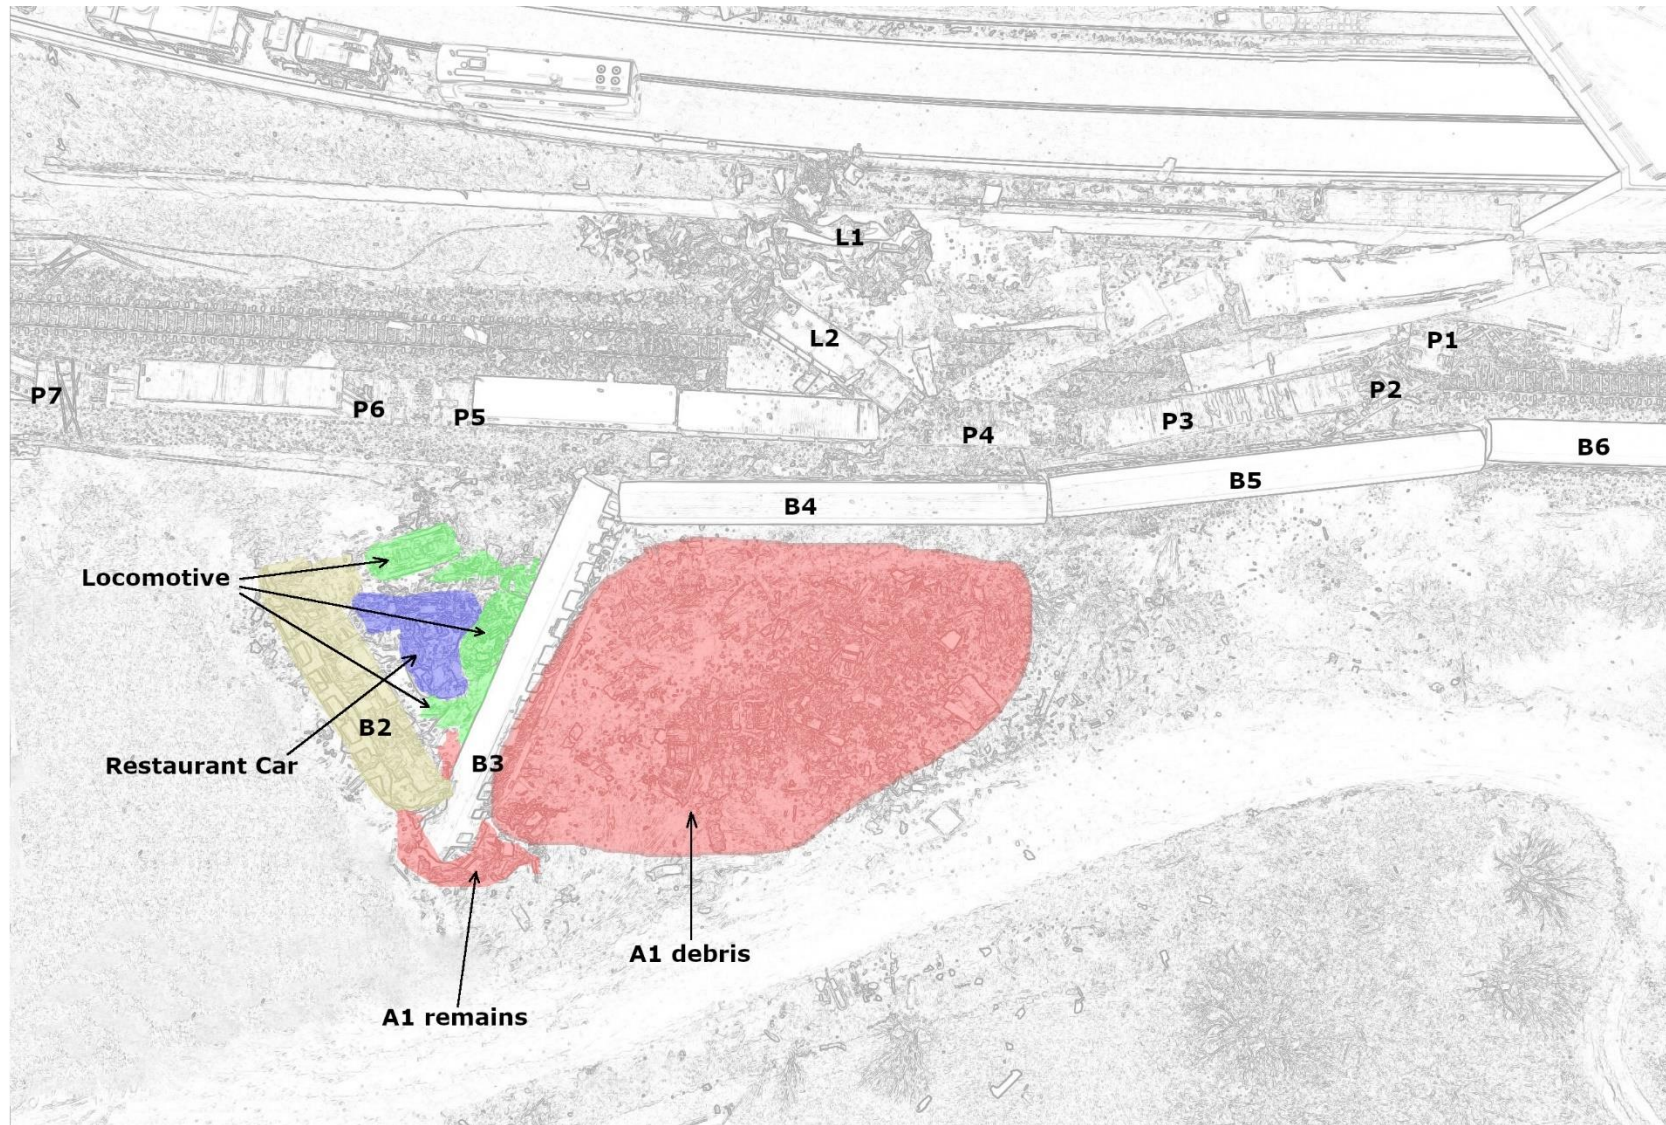
Figure 12. The accident site.

Best estimated point of the 1<sup>st</sup> collision: **X**, Freight locomotive 120-022: **L1**, and 120-012: **L2**, Passenger train locomotive 120-023: **Locomotive areas**, First-class A1 coach: **A1 areas**, **Restaurant Car** area, Second-class **B2** on B3 head, then **B3**, **B4**, **B5**, **B6**, (B7 under the tunnel), Freight train platforms **P 1-2-3-4**, and freight wagons 4-7 (and other 6 not on the figure).

- 132 The passenger train locomotive 120-023 follows a slightly leftward path in its driving direction towards the lower verge, where it hits the ground, followed by the first-class passenger car. Due to the very heavy initial impact, this 120-023 locomotive has been completely destroyed (Figure 17), and its parts were found at an angle of approximately 20 degrees to the left and at a distance of 30 to 45 meters. The A1 coach of the passenger train was completely broken up due to the extreme mechanical loads of the impact and its heavier parts followed a path close to the path of the locomotive parts, at an approximate angle of 25 to 30 degrees to the left. Its lighter parts (seats, internal panels and fittings, luggage, and all casualties) were scattered in a wider area before the end position of the vehicle (see global Figure 12).

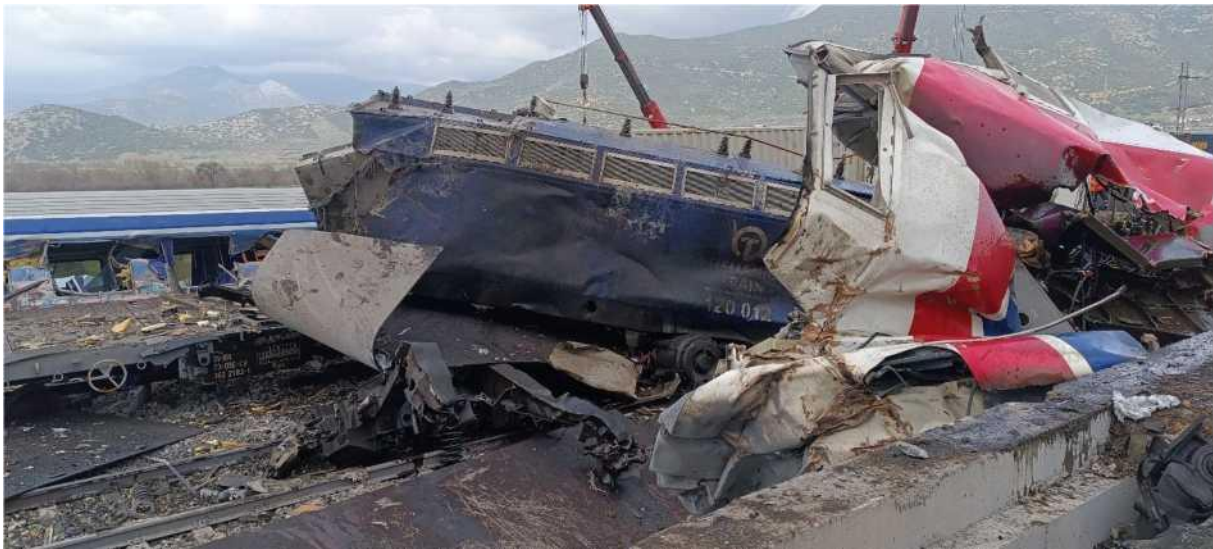
Figure 13. Locomotives 120-022 and 120-012 of the freight train 63503 after the accident. Front view, from the road.

138 By comparing the damage to the steel plates and the Restaurant Car, it can be considered as most likely that the initial impact to the Restaurant Car came not on its front bumper but underneath its “belly”, indicating that the Restaurant Car had a slightly “nose-up” attitude at the moment of the impact, which is consistent with the damage observed on the first and presumably topmost steel plate that was found wedged underneath the blue 120-012 locomotive. Meanwhile, the 1st platform of the freight train sustains very heavy damage from the impact with the Restaurant Car that leaves it bent in half and wedged under the remaining steel plates against the wall, and spread few meters after the collision, in the area before the entrance of the tunnel. (Figure 13, Figure 22).

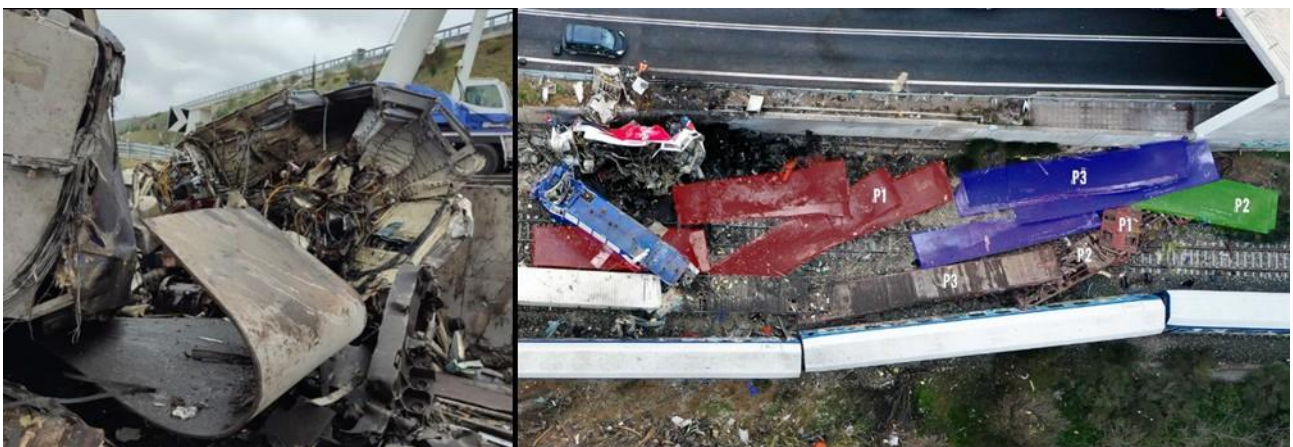
Figure 22. Remains of the top steel plates and final position of the 3 sets of steel plates.

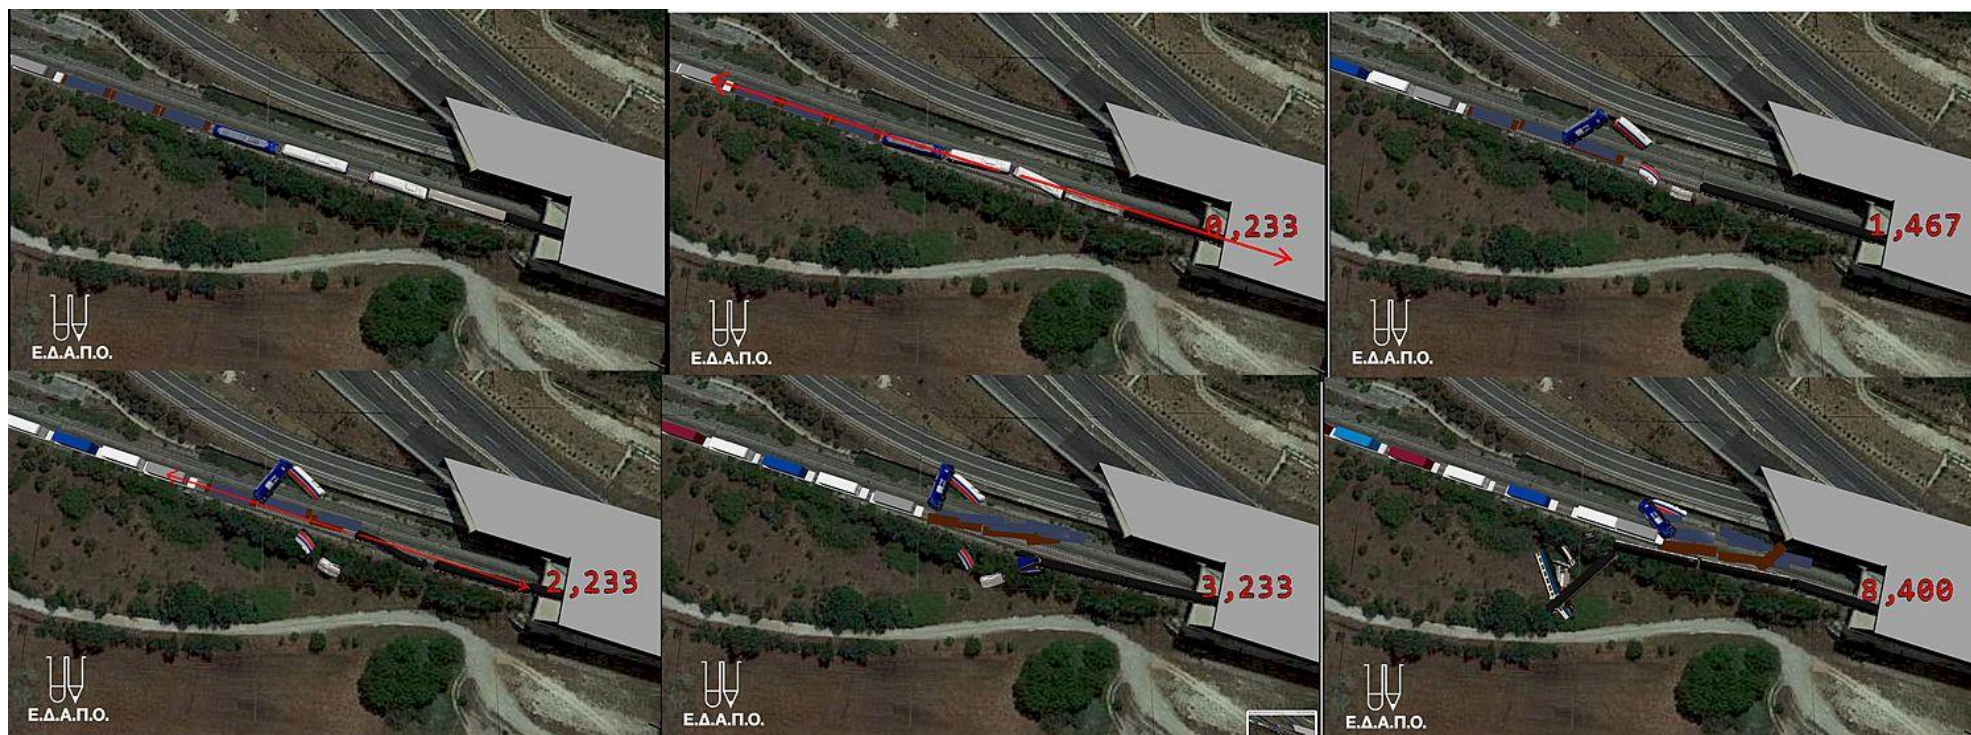
- 144 Finally, the fourth wagon of the freight train carrying a shipping container, hits the second freight locomotive 120-012 and then comes to a standstill. On the next page (Figure 26), a set of pictures extracted from an animated sequence proposes an overall view of the collisions with their timestamps: image 2 showing the 1st impact, image 4 the 2nd impact and images 5 and 6 the movement till standstill.

Figure 26. Overall view of the simulated accident mechanism with the timestamps: image 2 showing the 1<sup>st</sup> impact, image 4 the 2<sup>nd</sup> impact and images 5 and 6 the movement till standstill.

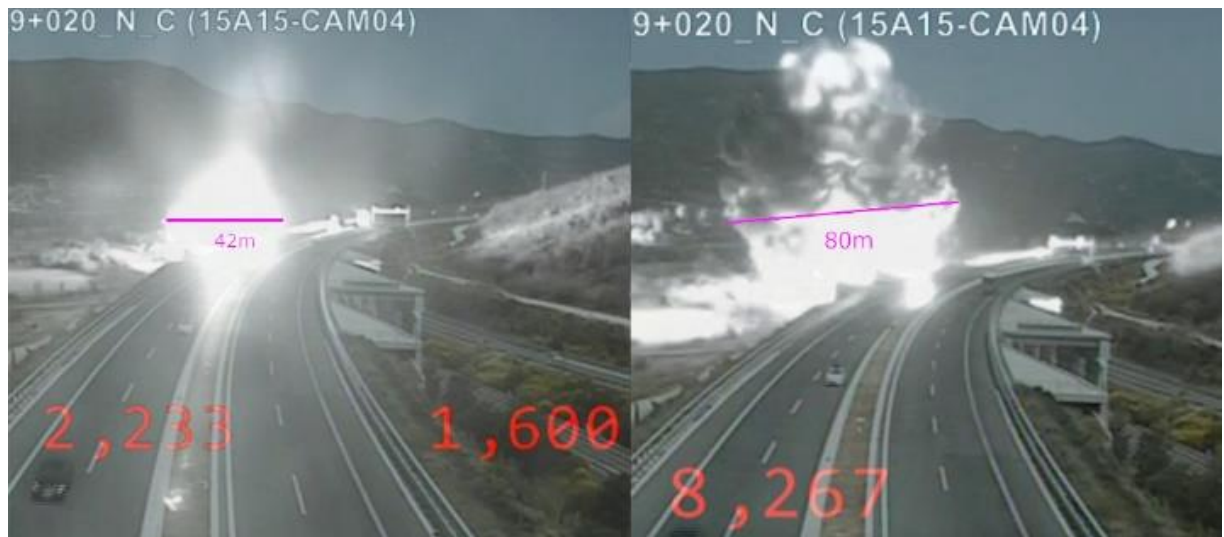
- 147 At the same time, the catenary lines themselves (both lines, one for each direction of travel) have been ripped off due to the collision, but the power was already cut within 0.2-0.3 seconds of the short circuit. Approximately 0.3 seconds after the end of the arc flashes, a fireball starts forming from the ground level and very rapidly expands upwards to a size of approximately 42 meters in diameter, which burns for approximately 2 seconds.
- 148 At approximately 2 seconds after the initial ignition, a second stage starts, when a new fire plume can be observed, moving northbound, away from the 1<sup>st</sup> stage fireball. This new fire plume is feeding the original fireball until it grows to almost double the size (80 meters) at approximately 4 seconds after ignition (Figure 28, Figure 29, Figure 30).

Figure 28. First (left) and second stage (right) of the fireball.

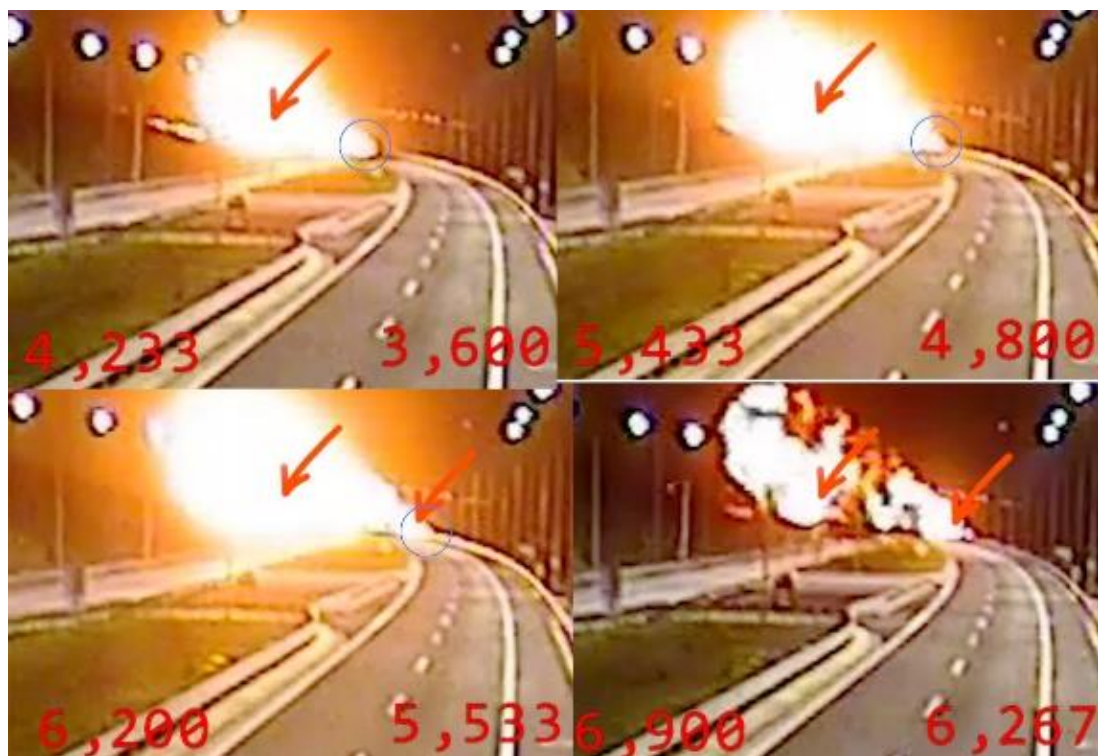
Figure 29. Second stage, fireball (left side of pictures) and fire plume (right side of the pictures)

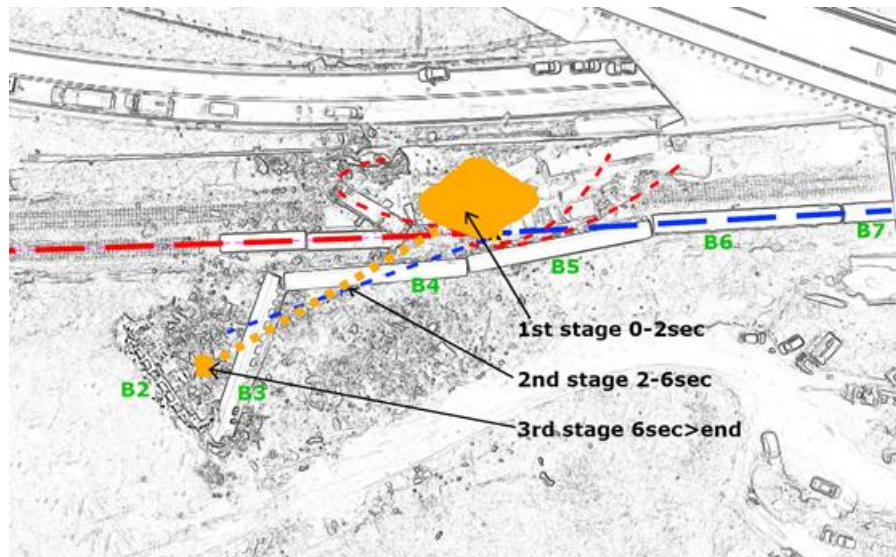
Figure 30. Clarification of the sequence with its timing.

- 439 As described before (3.9.3), observing the course of the fire gives rise to making a distinction between 3 different stages (Figure 30, page 47):

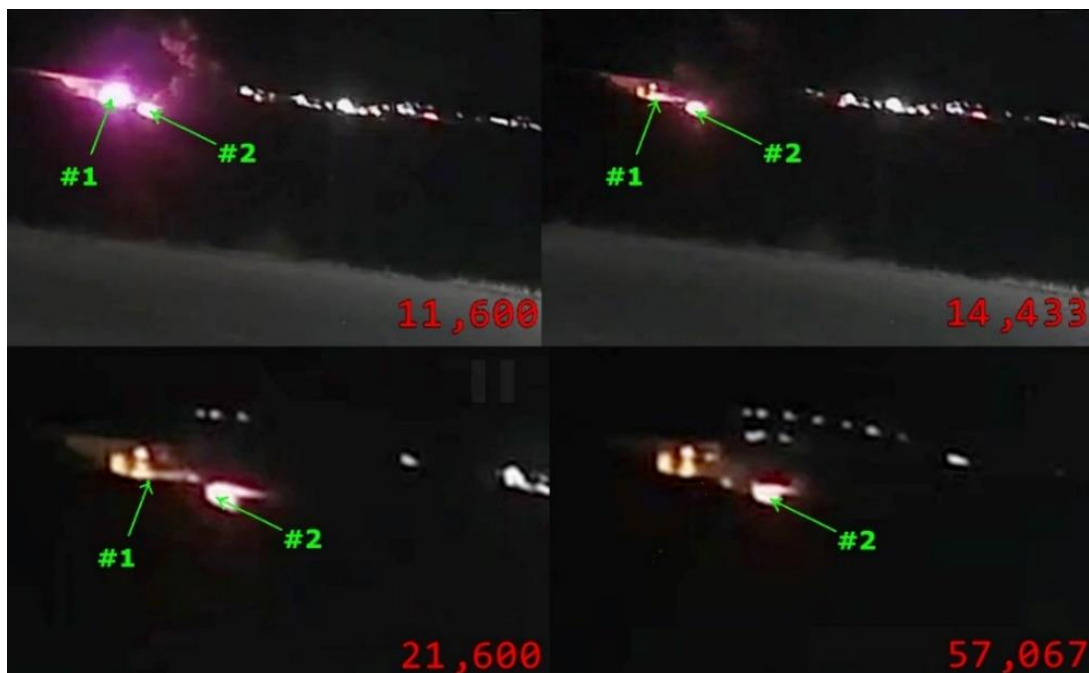
151 Pool fire #1 can be seen burning brightly, near the locomotives of the freight train, for approximately 30 seconds. After that, it continues for an unknown period of time burning with smaller flames that can be seen from passenger videos but not large enough to be recorded by the remote cameras overlooking the scene. The video evidence shows stronger flames for 20 seconds and then a decrease in flame size that hides the fire from view, so it is not possible to accurately estimate the duration of this pool fire.

- 152 It is most likely that this pool fire #1 at some point heats up the silicone oil inside the transformer of the first freight locomotive 120-022 and smaller amounts of silicone oil having already spilled at the area and an additional amount draining from the cracks of the transformer case. This creates a smaller secondary fire of the silicone oil that can be observed in passenger videos 20-30 minutes after the collision and its location and size can be traced by the white residue ( $\text{SiO}_2$ ) that indicates burning of silicone oil as it is observed at the area after the fire.

- 153 **Pool fire #2** is burning with a very strong flame for at least 60 seconds before other combustible materials are added (flame color change), which made fire continue to burn stronger for at least 60 minutes after the collision. This fire has grown so strong in the first 30 minutes that the first firefighting effort at 00:02 (43 minutes after the start of the fire) from a single fire truck pumping water from the railway lines to the fire below, had minimal to negligible effect.

Figure 31. Pool fires #1 and #2

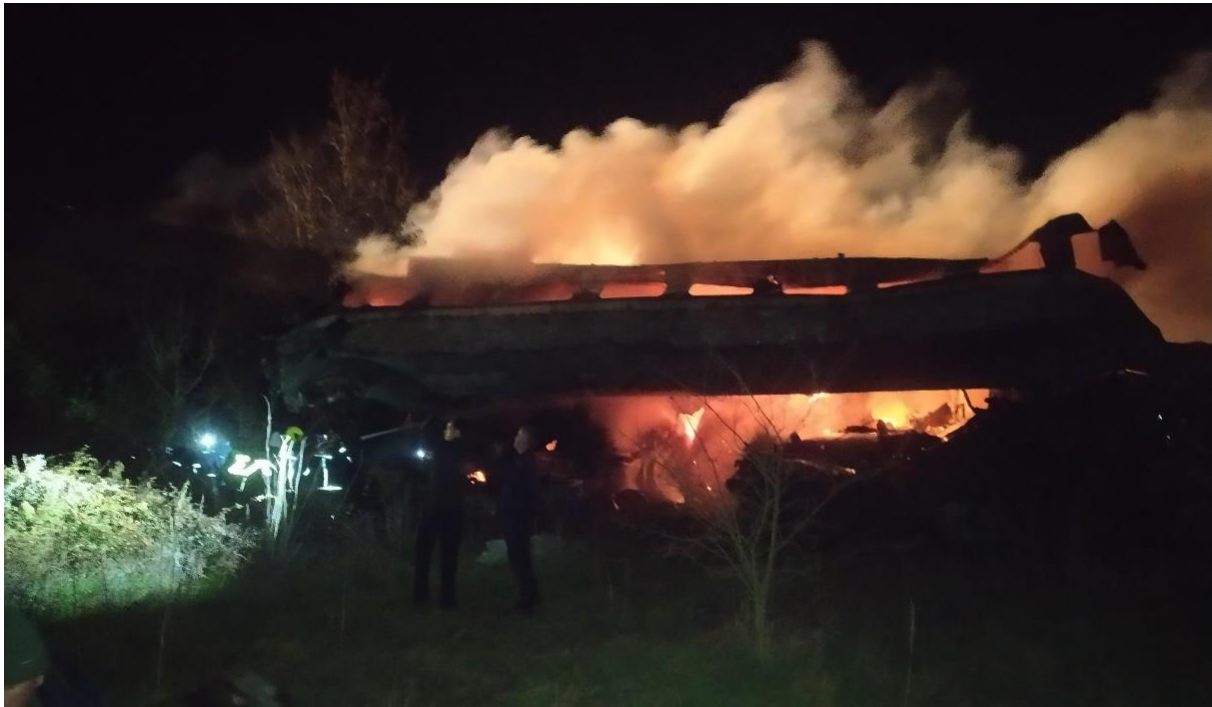
156 At 02:12 a photo (Figure 34) of the accident site shows the heavy fire at the Restaurant Car being reduced, with still fire and heavy smoke coming out from the remains of the Restaurant Car and with another two small flames remaining at the front and rear of the B2 coach. A firefighting effort recorded at 02:32 shows foam being pumped towards the carriage, without being clear if it played a role in the actual extinguishing of the fire that had already consumed the total length of the carriage.

*Figure 34. Photo showing the heavy fires in the Restaurant Car area (behind), and on the B2 coach (front, above) (Source: EDAPO).*

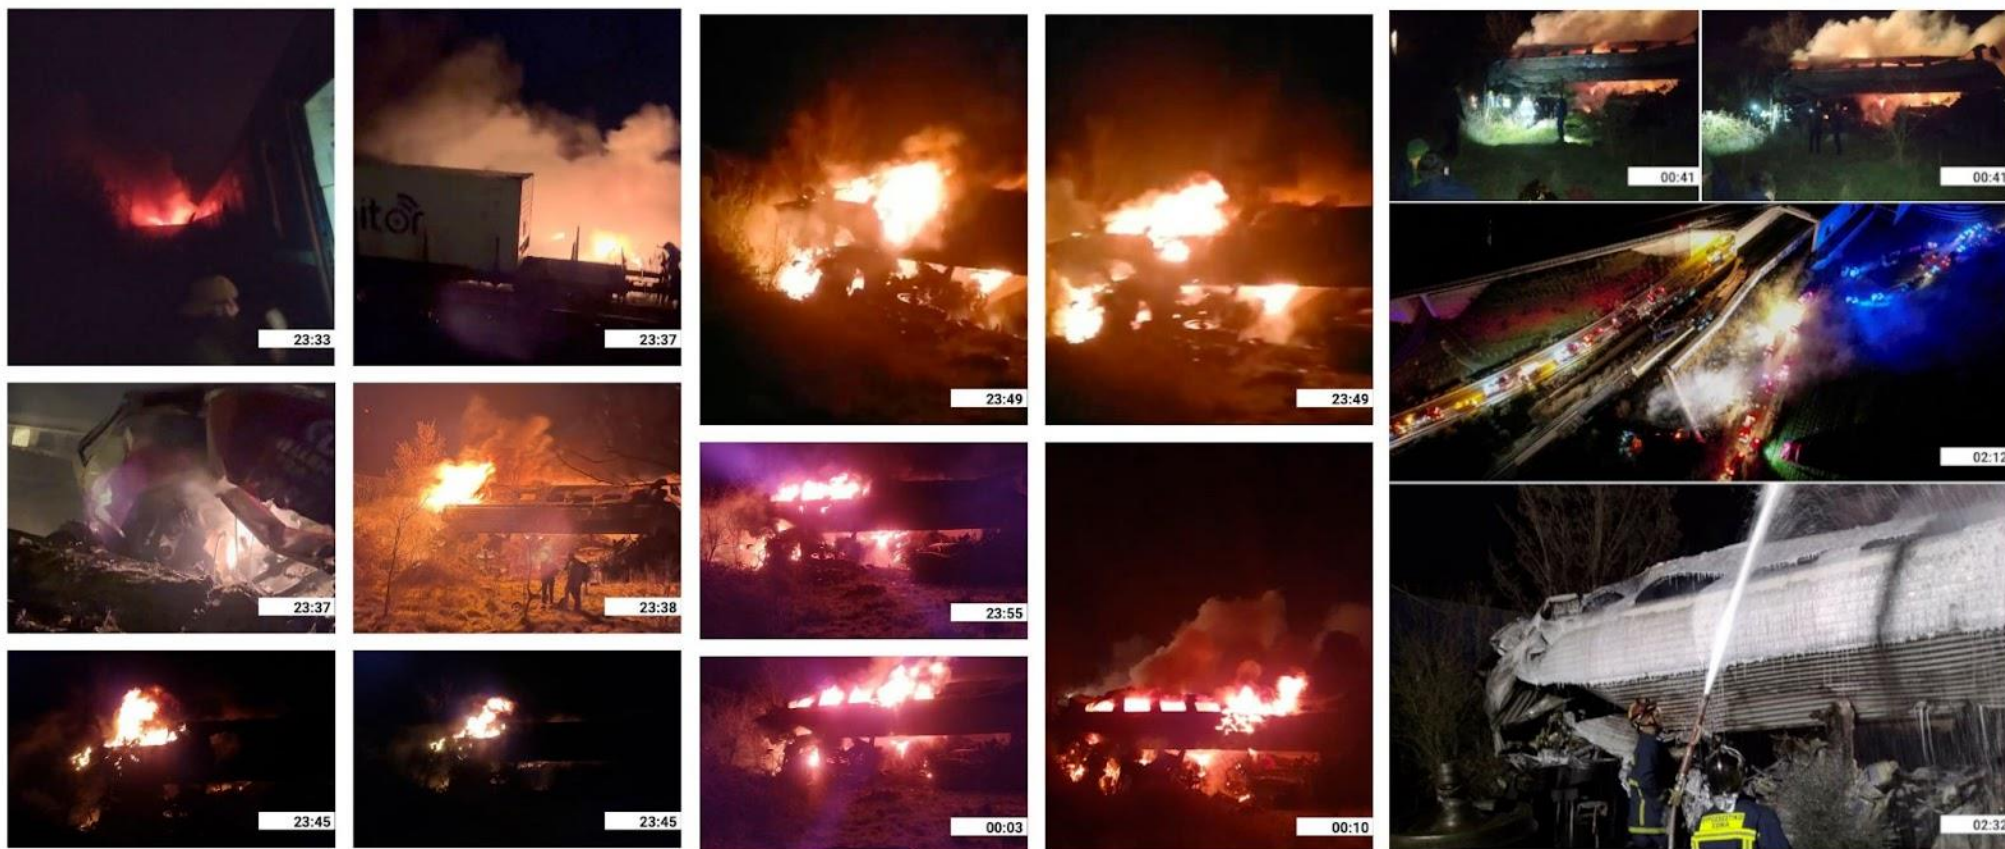
157 From the work of the EDAPO team of investigators, more details and a rebuild of the timeline of the fires are available, with timestamp on photos (Figure 35, next page). This timeline describes the development and decay of the fire (source: EDAPO).

Figure 35. Photos of the fires development and their timestamp (source: EDAPO).

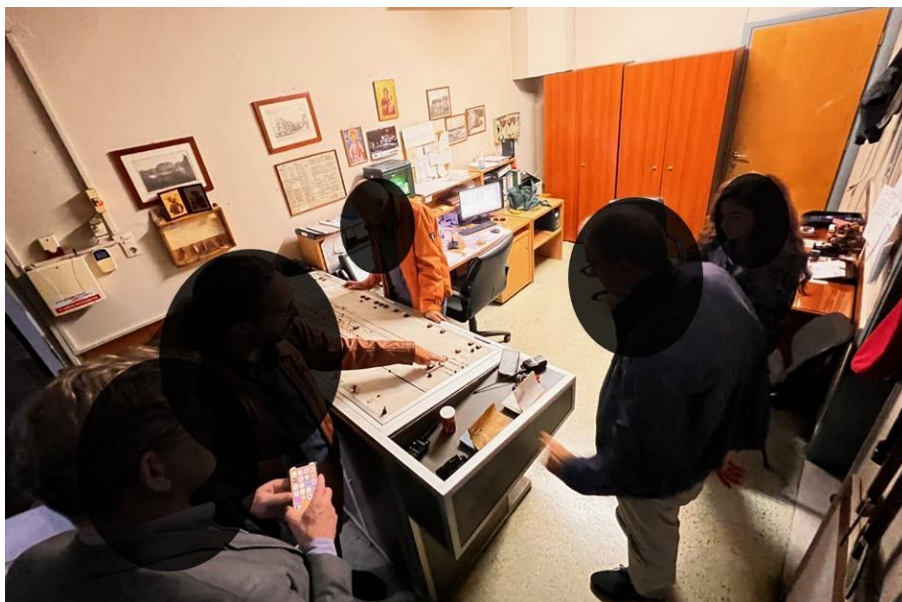
| 6.2. | Other recommendations..... | 140 |

*Figure 36. The traffic control room with station masters at Larissa Station.*

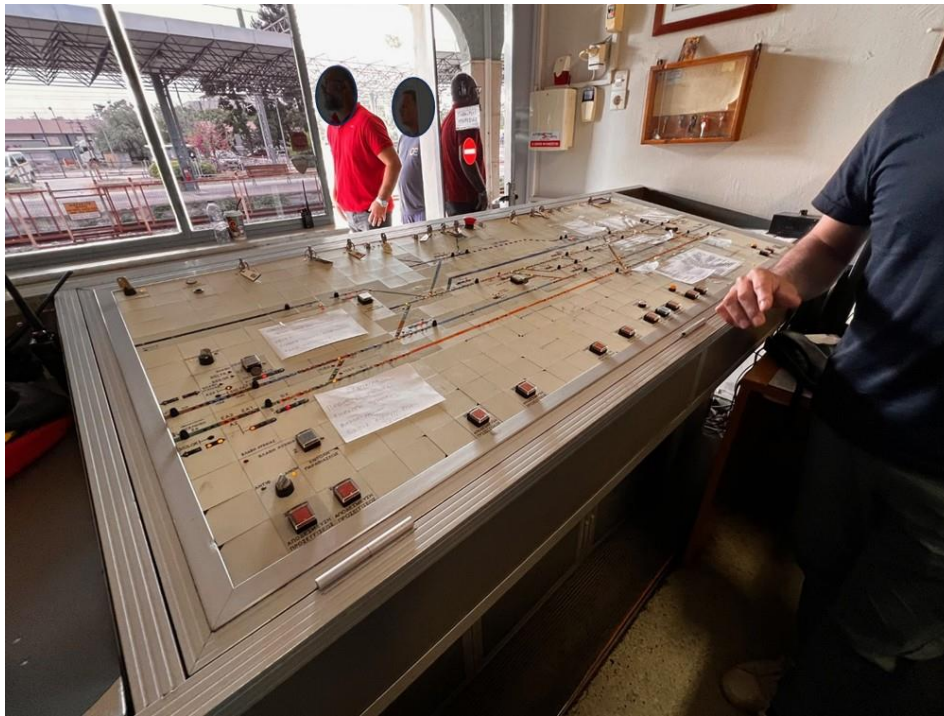
Figure 37. The control panel at Larissa Station

- 189 As it can be observed on the global photo of the control panel (Figure 37), it is a large area with many information and commands that cannot be considered at a glance. To pass from one mode to the other (manual mode to or from automated mode), the station masters must turn a numbered key (the number refers the number of the switch) on the top of the control panel (Figure 46), separately for each switch. The area where to read the switches numbers is small and partially hidden by the plastic and metal key rings (this point is further analysed in the chapter 4.2.2). In the actual practice of using these keys, as it has been explained and shown on site, at least two ways of manipulating them co-exist, one of them being indicative of lack of trust in the system and/or lack of experience (4.2.1.3).

- 243 The indications on the position of switched 118 are small indications, on two distinct positions, on a larger Control Panel (the information of the Figure 47 among the ones from the whole Figure 37).

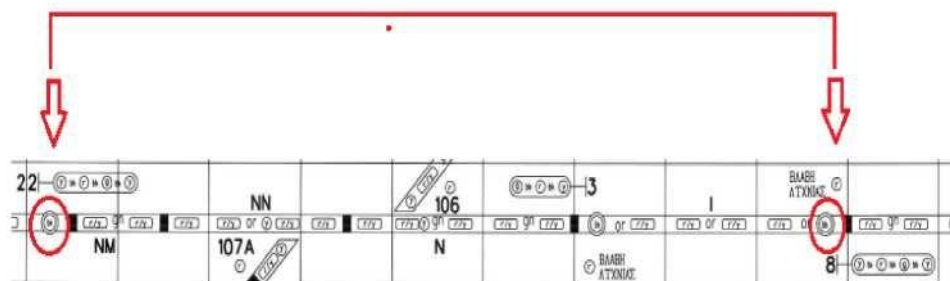
- 188 The normal operation method of the control panel for the movement of electrically driven switches and the opening of the light signals that will allow for a train to pass, is the simultaneous control of two buttons that automatically set the route (Figure 38).

Figure 38. "Automatically setting" the route for a train as explained in the Control Panel manual<sup>5</sup>.

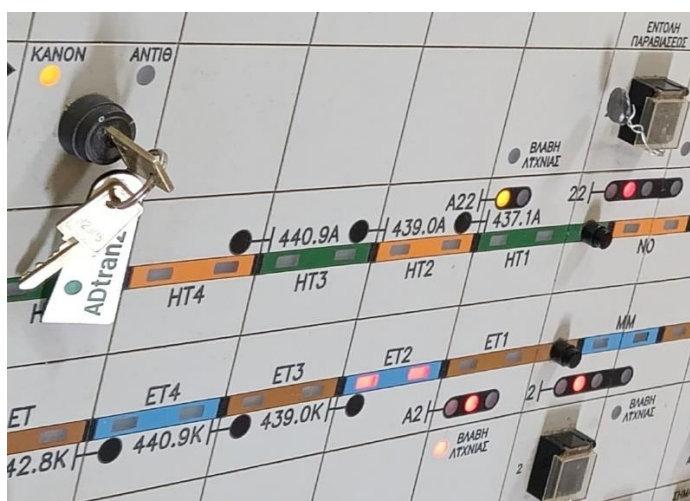
- 190 Considered as a global tool, the control panel remains a complex and partial representation of the station real-world site. In particular, as it can be understood by observing the manipulation of the control panel, distances and time are treated in a different way: while the space is schematised and contracted, time estimation remains implicit, being inferred by the station masters without knowing the actual speed of the trains. The position and movement of trains along the lines are represented by the lights (Figure 39), lighting on (when passing) and off (when passed). While it takes an experienced station master a few seconds to process the passage of a train, it is different for novices (confirmed with several of them). It is clear that this tool generates moments of uncertainty and stress (this point is further analysed in the next paragraphs, and 4.2.6) during both the ‘information processing’ and ‘command execution’ stages of their actions.

Figure 39. Position and movement of trains, here in the section ET2 depicted on Katerini Station control panel.

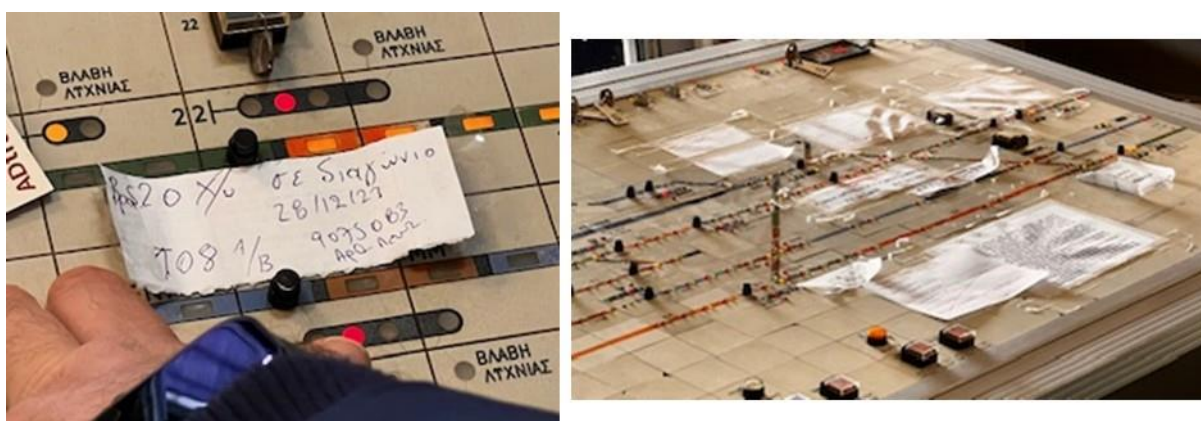
- 191 The Larissa control panel in the station masters' traffic control room, as well as others in actual operation (Figure 40), is supplemented by pieces of paper “taped” or just “laid” on the inclined panel. Their operational function is to remind the station masters of important local information on operational restrictions or degradations, some for a few hours, others for months (and even longer).

Figure 40. Useful pieces of information.

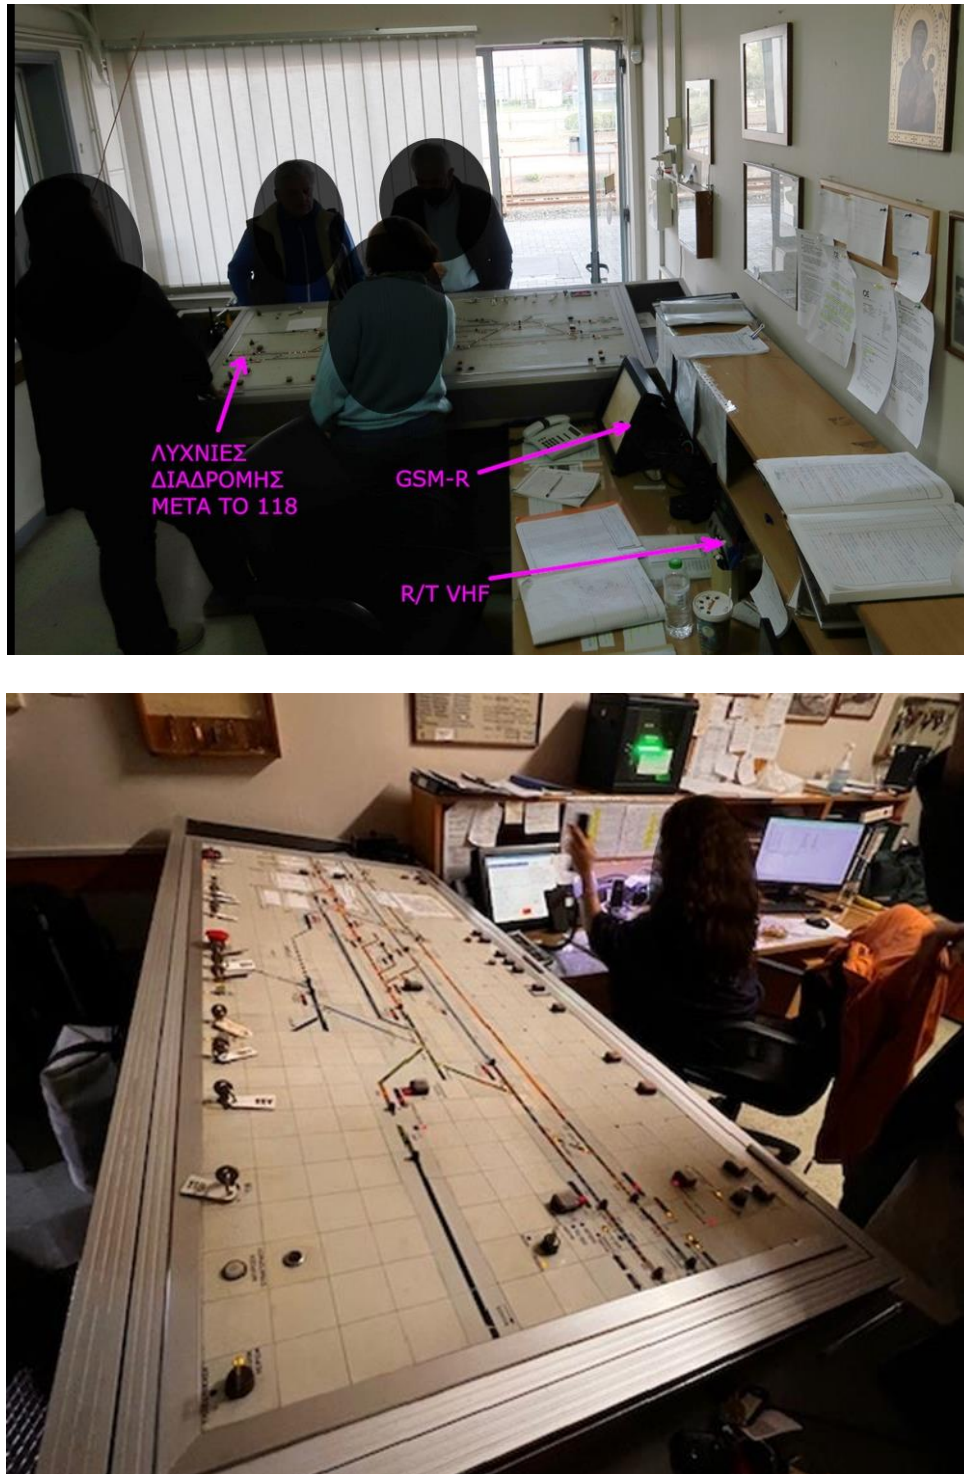
- 192 Taken together with another source of influence, namely the numerous communications (as analysed in point 4.2.1.8), in the period of time just before and while the control panel was showing the passage of train IC-62 (240), it should be noted that this panel and the communications area are organised and physically positioned in a way that makes it very difficult to perform both tasks at the same moment. In morning and afternoon shifts these tasks are performed by two station masters in order to avoid excessive workload. When you are concentrating on communications, you are turned sideways in relation to the control panel and the LEDs that are lit in this case are behind you (Figure 41. Positions of station masters when facing the control panel (above) and when

- 193 ). This directly, logically and naturally explains how Larissa's station master did not 'see' or 'look', and therefore did not 'detect' the train's passage towards the descending track (4.2.2). During the investigation, 2 other situations were identified by the investigation team: one in which the station masters had adapted it and added a desk just in front of the control panel (Figure 42), and the other one, in Athens, when a Station Manager reported this as an issue and their manager made the situation more adapted.

Figure 41. Positions of station masters when facing the control panel (above) and when communicating (below) in Larissa station.

- 245 Furthermore, the way the communication means (VHF console, GSM-R and telephone) are positioned on the right of the control panel and at a lower level (Figure 41). This means that, when occupied with whatever communication and logically directed towards the used means of communication, the indications related to the position of switches 118 and the departure of train IC-62 were situated behind the left shoulder of the station master in the left bottom corner of the control panel and so in practice invisible (192).

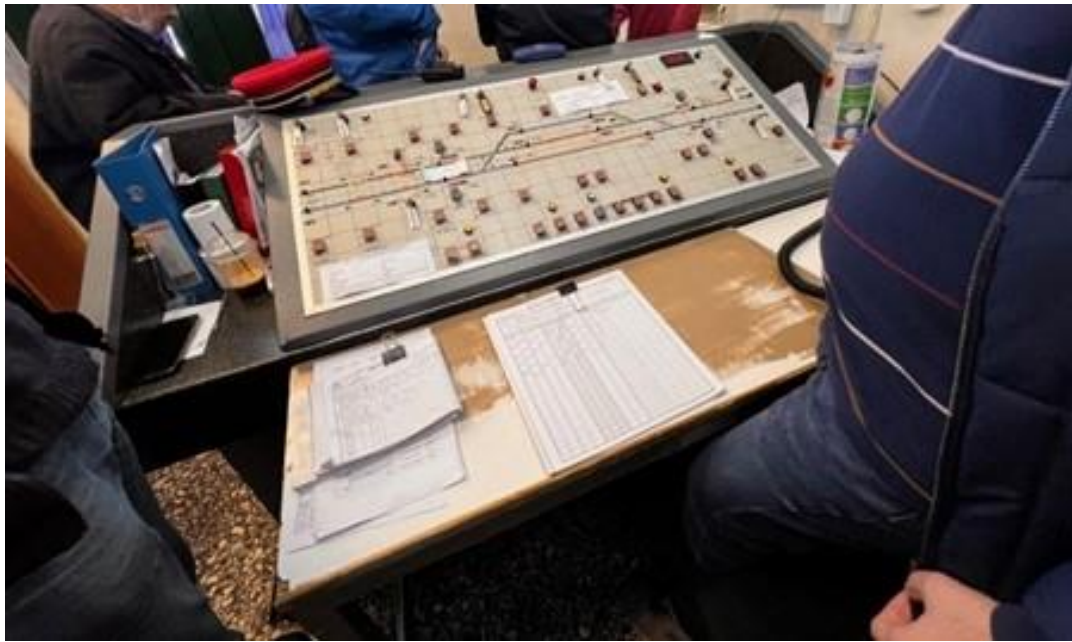
Figure 42. Position of the station masters having adapted their own desk (Station Afidnai).

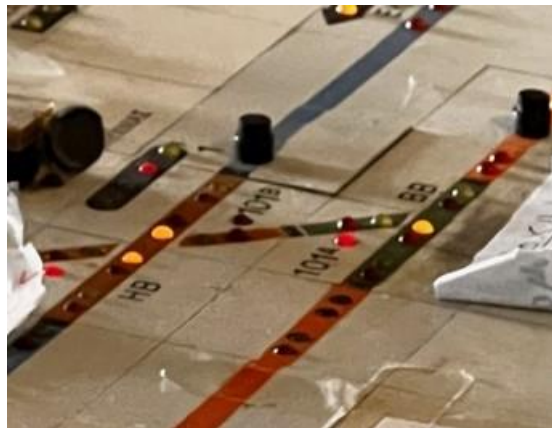
Figure 43. Switches 101A/B

- 214 Due to a problem with the overhead line that occurred earlier that day, traffic between the station of Paleofarsalo and Larissa was operated on a single line (92). This requires additional attention as well as specific communication between both station masters. Furthermore, this also requires an additional action for the trains that enter Larissa from Paleofarsalo from the descending track because the switch-combination 101 had to be turned into the bypass position to allow them onto track 2 in Larissa station (Figure 43).

- 215 Due to technical problems the switch 101A could not be operated remotely (94, Figure 43), via the control panel. To be able to maneuver the switch in the desired position, the station master has to instruct the local switch operator who in turn has to walk towards the switches and fix them in the requested position with a physical intervention. The station master in Larissa instructed the local switch operator at 22:46 to position switches 101 in a bypass position, directly after being informed by the station master of Paleofarsalo that train IC-62 had left for Larissa. At 22:57, the switch operator informed that the activity was performed.

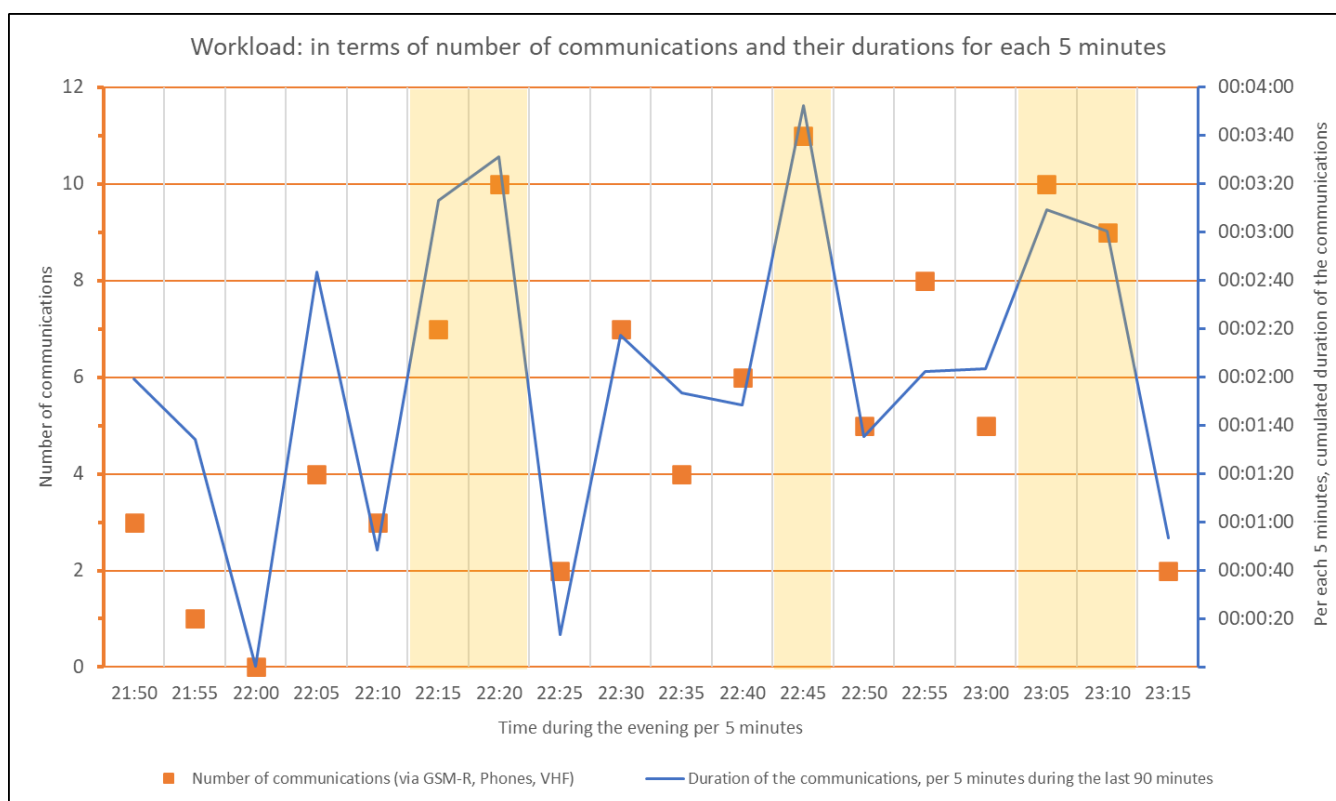
- 220 Analysis of only the communications, not even taking into account other tasks, indicate three peak periods (Figure 44) that appear to correspond with the consecutive mistakes made by the station master: setting the routes for respectively the train 2597 and IC-62 and not detecting the mistake with switch 118. This indicates that periods of too heavy workload, in particular for less experiences operators, can be a direct cause for errors, mistakes and routine violation, because there is “no-time-to-think” or one is “captured-by-the-flow-of-issues-to-contain”. This type of workload analysis, with results beyond human capabilities, shows the importance of integration human and organisational factors in risk management practices (4.2.80).

Figure 44. Factual analysis of the communication workload as a risk to be taken into account during HOF integration.

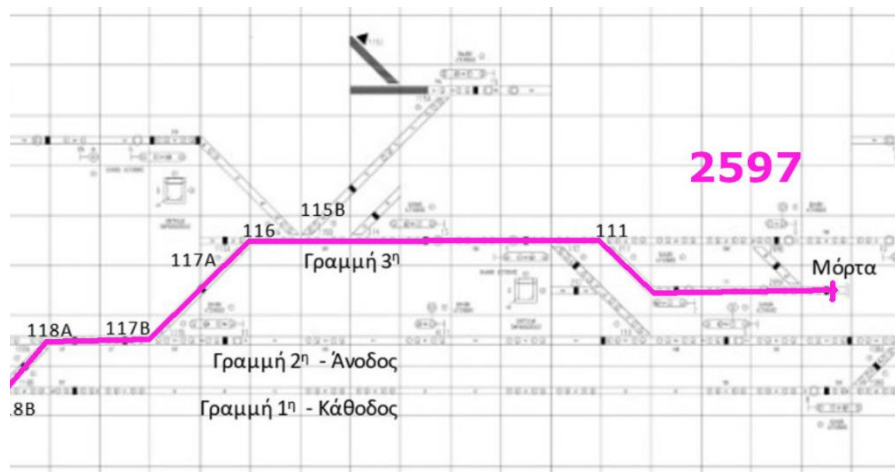
- 222 Approximately around 22:35, after having received a call from the train driver of train 2597 that he was approaching the station, the station master of Larissa manually set the route with the intention for train 2597 to enter Larissa station from the north and be guided to the dead-end track between tracks 2 and 3.
- 223 This would require the setting of switches 118A/B, 117 A/B, 116, 115B and 111 to be turned in the adequate position (Figure 45). Note that this is also the action that directed switches 118 in the bypass position. Before that, these switches were turned in the straightforward position at 22:12 for the entry of train IC-63. From the recorded actions on the control panel, it can be seen that this was the last time before the departure of train IC-62 that the switches 118 were manipulated through automatic route setting.

Figure 45. The route for the entry of train 2597.

When manually setting the route for the entry of train 2597, the station master of Larissa forgot to turn the switches 116 and 115B in the correct position. On other occasions these switches would have been in the right position after the entry and acceptance of train 2575 from Volos on track 3. Earlier in the evening, on the 28/02 this train 2575 was positioned on track 6 at 22:10 by the station master of the afternoon shift because track 3 was occupied with train 2594 that had been brought back to the station at 21:30 after traction problems arose on its way to Neoi Poroi (93).

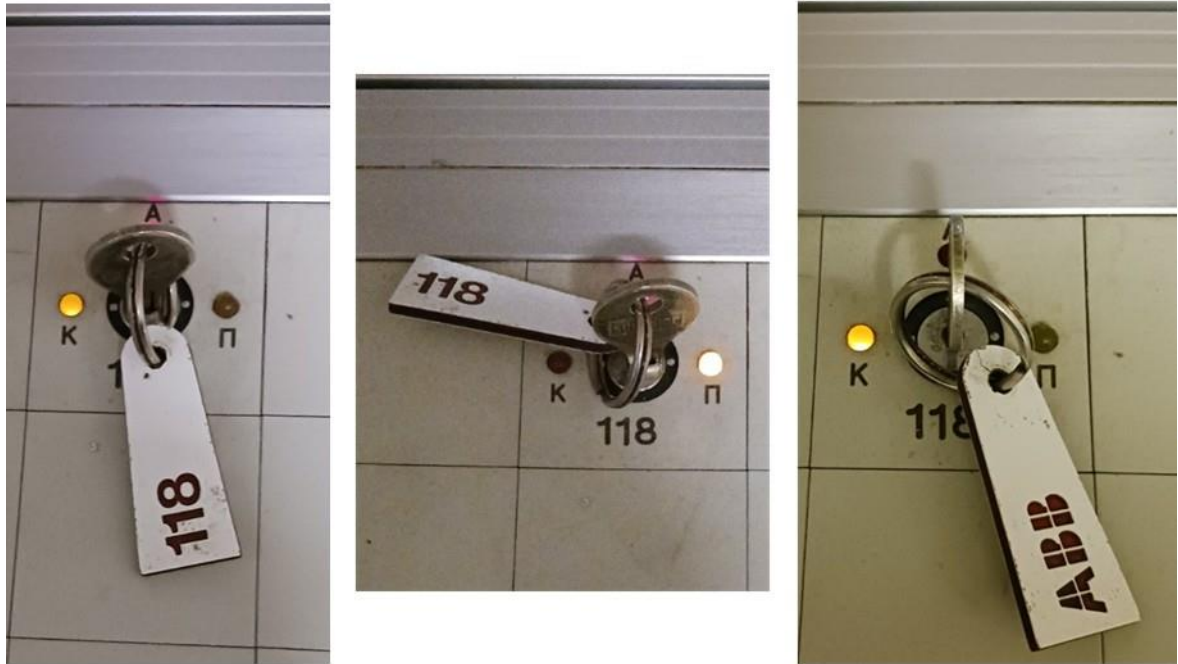
- 236 On the upper part of the control panel, there are three-position keys that are numbered according to the electrically driven switch they handle. These keys are used for the independent, manual control of any electrically driven switch. Turning the key from the central position by 90 degrees counterclockwise will command the switches to move to the "main" position (indication "K"). Similarly, by turning the key 90 degrees with the clock, the switches are commanded to move to the "bypass" (indicator "Π") position. When there is a correspondence between the physical position of the switches and their control key, the yellow light diode for the indicated position of the switches is lit steadily. Above the key of each switch, there is also a red light diode, in the central position marked "A". This is the position the key should be put in to allow for "automatically setting" the routes. (Figure 46).

Figure 46. Detail of the three-position key for handling switches 118 on the Larissa Control Panel.
