Rail Accident Report

Head-on collision between a passenger train and a freight train  
in Tempi, 28 February 2023

RL01-2025, 27 February 2025

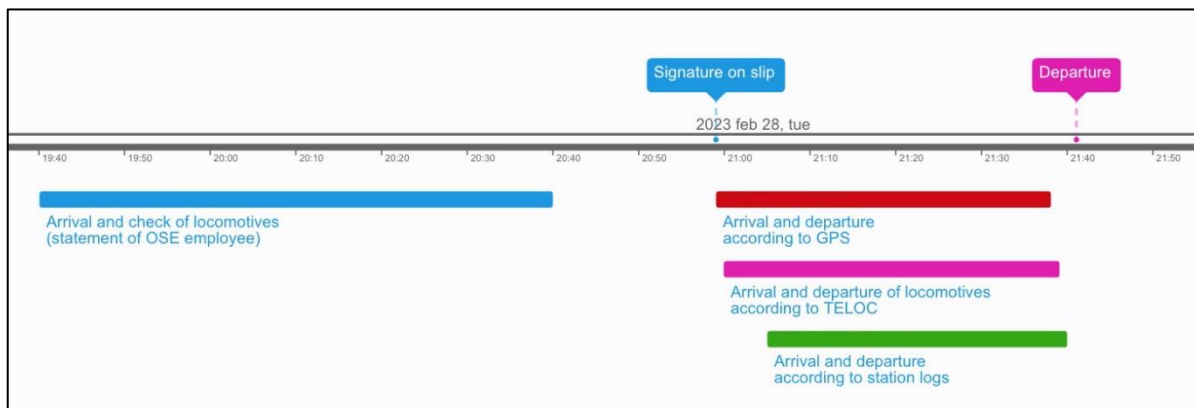
- 284 The same timeline of events is supported by GPS data of the movement of the locomotives as provided by Hellenic Train. A similar timeline is supported also by the logbook of the station master at Thessaloniki Freight Station (locomotives arrive at 21:05, test finished by 21:35 and train leaving at 21:40).

Figure 51. Timeline of the movement of the freight train 63503

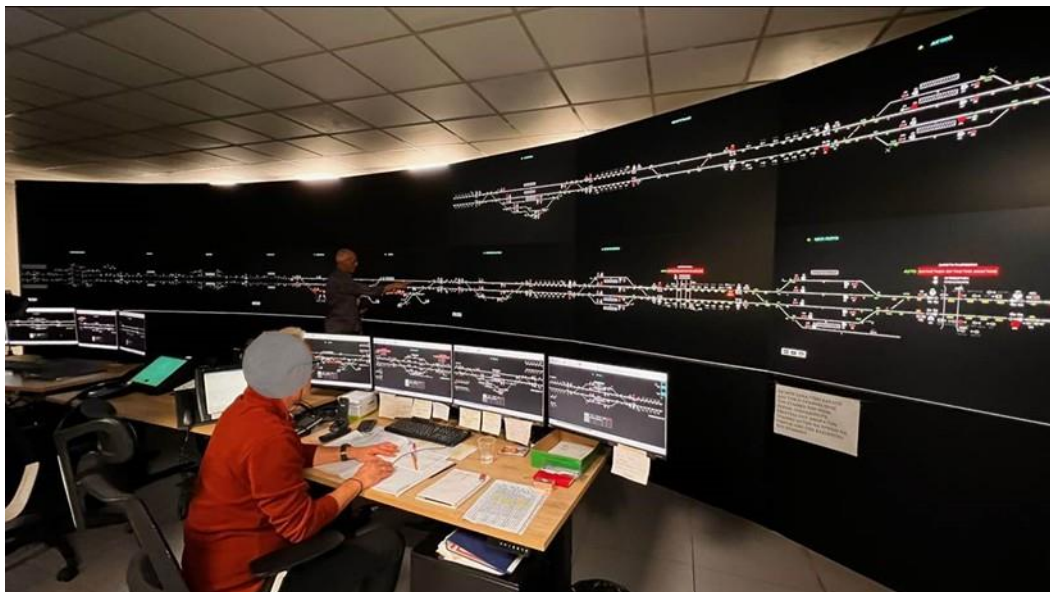
315 Another level of performance monitoring is also possible through the digitalised traffic control rooms (note that such a control room was not in place at the Tempi accident occurred), and this concerns the supervision of traffic in tunnels, and also, as in the example below, traffic management itself. As was observed during on-site visits (Figure 52), on several occasions during the investigation, it is clear that decision made via the control panel in Larissa station a few dozen meters further on (just as it could also be fifty or hundred kilometers) can easily be observed and supervised. However, it is currently not used in that way, and it is not clear if there is any intention to do so in the future. It was observed that there has been an effort to put into operation these traffic control rooms wherever infrastructure (signalling) is available. Their use, however, is still limited by lack of the maintenance of the switches. As a result, still large parts of the Athens-Thessaloniki route are not monitored remotely.

*Figure 52. Digitalised traffic control room in Larissa station, with experienced staff, in 2025.*

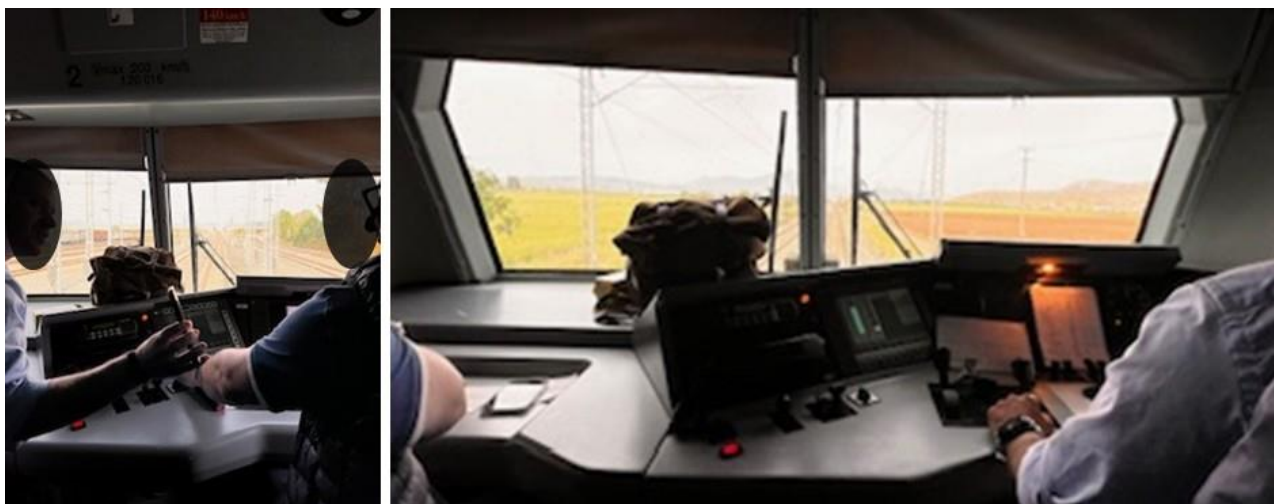
349 Another important part of the competence management system is related to non-technical skills, behaviours and attitudes. As previously reported (264, 265), in a context where two train drivers (and sometimes even more) are sharing the driving responsibilities in an alternate way (Figure 53), it is expected they benefit from a crew resources management training, developing their non-technical key competencies (ex. management of stress, of time, of anger, error detection and recovery, etc.). This would also include the capabilities, the willingness, and openness to solve and report any issue related to safety in a context of diverse interpersonal relationships (especially with issues related to obedience, power, and respect issues). This type of peer-review and/or crew resources management is useful when well framed and embedded in an open culture, and in the training of non-technical skills, and eventually contributing to the overall performance and continuous improvement. We could however not identify any structured approach and or guiding directions that would support this.

Figure 53. Photos of the train drivers crew, positions and alternance.

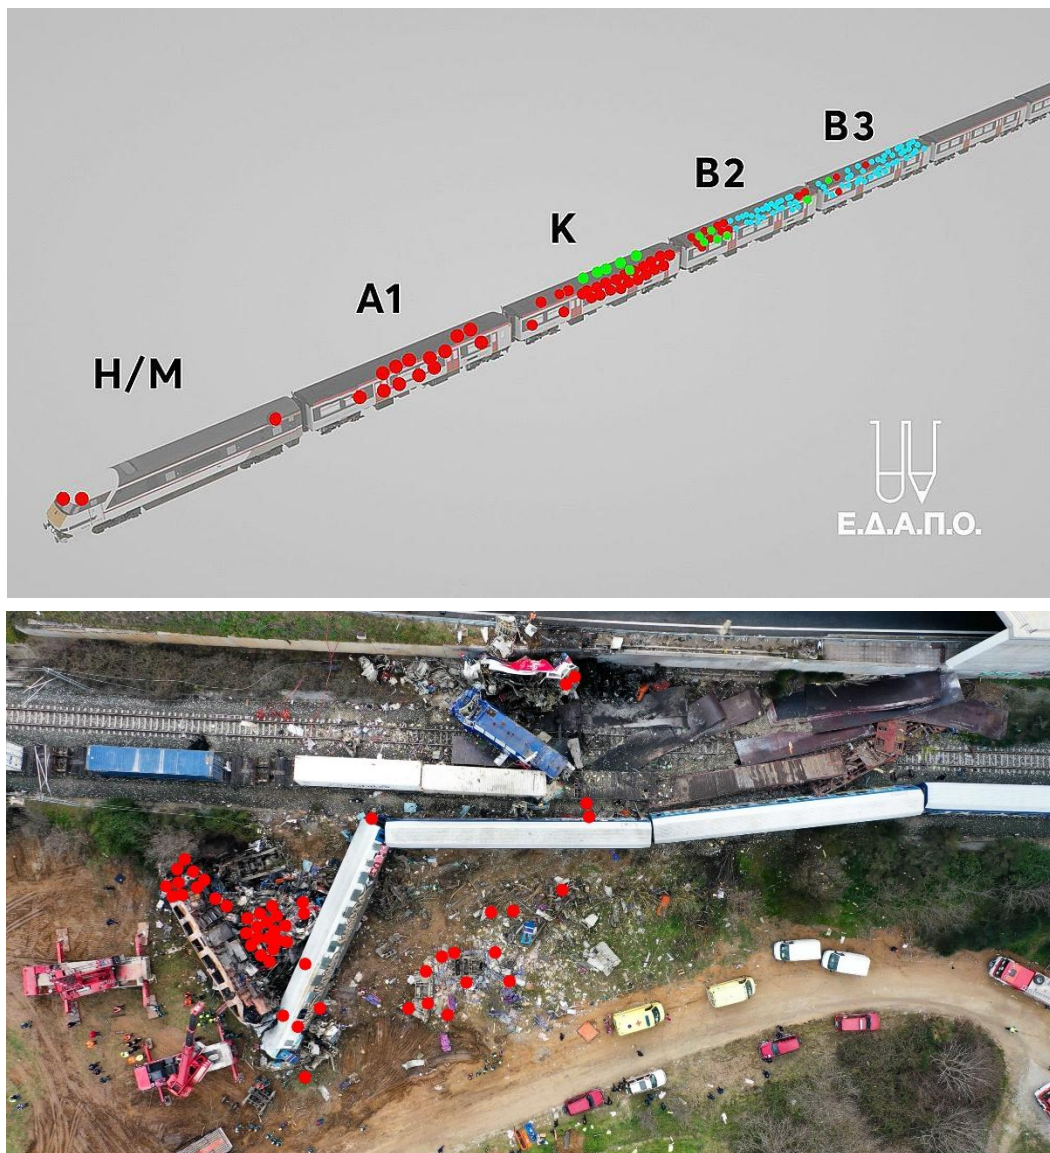
- 423 The B3 coach of the passenger train was not subjected to heavy deceleration forces and was totally survivable, if not for secondary impacts from the B2 coach hitting its roof and a section of the locomotive hitting against the side of the B3 coach. There were 2 casualties that both suffered severe head and spinal trauma due to impact by heavy debris entering through the side windows. Both casualties were killed instantly without any chance of survival, given the unlucky position they happened to be at (other passengers sitting next to them were practically unharmed). And 5 injured victims were ejected during the crash or jumped from a height to exit the carriage.

Figure 55. Initial and final estimated positions of fatalities, visualised on the scheme of the impacted part of the IC-62, and on-site.

- 445 Of the total length of the passenger train IC-62, the only parts that were totally consumed by the fire were the rear part of the Restaurant Car (letter K on the drawing, Figure 55, page 91) and the B2 passenger coach.

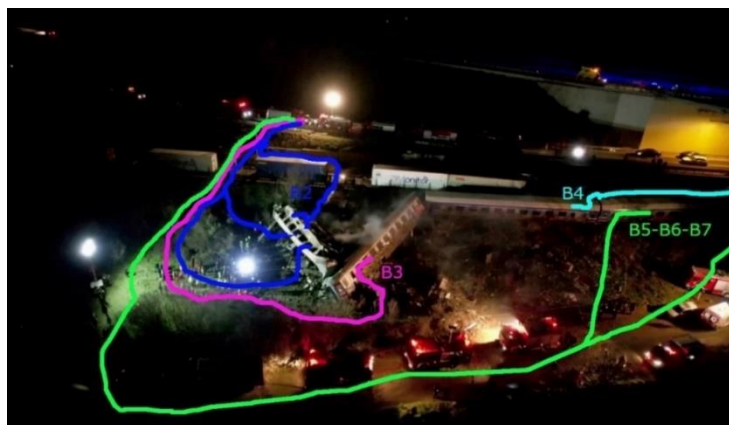
- 427 Passengers from coaches B4 to B7 managed to operate the emergency handles of the doors and open the doors to self-evacuate successfully. On the B3 coach, access to the front doors was limited due to parts of the roof collapsing and blocking the narrow passage to the door. Passengers chose to break a window on the left side and climb down from there in order to self-evacuate. The Fire Service used the same window in order to enter and evacuate 3 casualties and 3 injured passengers who were trapped and needed mechanical tools to release them.

- 428 At least two passengers sustained serious injuries (bone fractures and dislocations) during evacuation: 1 female passenger jumped from the top row of windows of the B2 coach and was injured by falling on debris below (subsequent passengers jumping from the same window avoided this by throwing their luggage to land on top of softer surface) and 1 male passenger who was the first to jump from the B3 coach front left window, sustained serious injuries by falling on debris below (subsequent passengers evacuating from the same window took care to climb down carefully in order to avoid injury). An unknown number of passengers were reportedly lightly injured during evacuation, mostly in a similar way.

Figure 56. Self-evacuation paths of passengers before emergency services arrived at the scene.

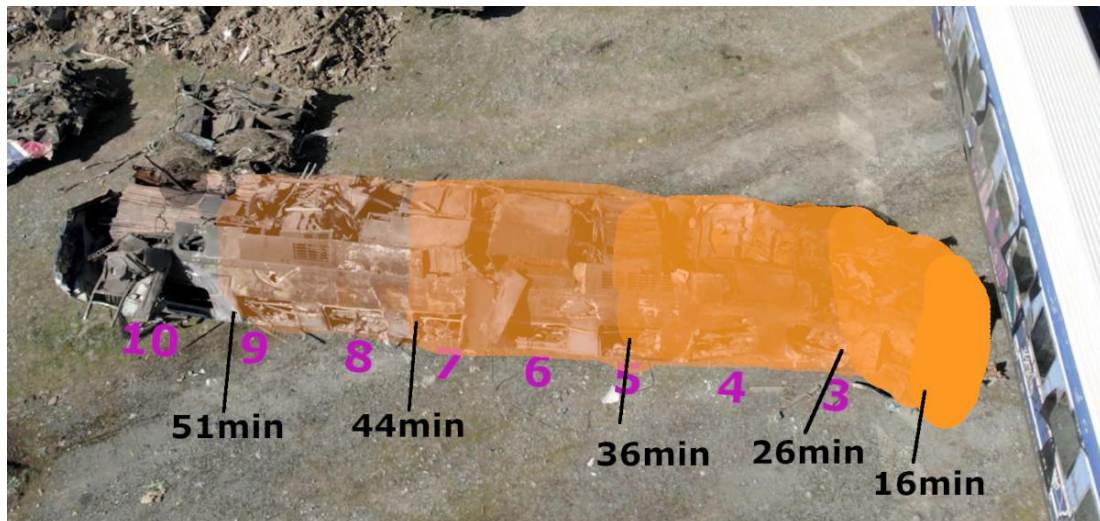
449 This secondary fire of the B2 coach started from the bottom part and in due course (around 23:35) went up to the front part of the B2 coach and consumed the entire length of it, without any active firefighting until the fire reached the end of the wagon and started to threaten the B3 wagon (Figure 57). By 23:38 or after about 16-20 min, the front of the B2 wagon had started to burn with very strong flames. After that stage, this fire did not show any abnormal or unexpected speed and flame strength (Figure 57). The slow speed of this fire is consistent with a fire that feeds on the upholstery, the fittings and the construction materials of the carriage itself, without the obvious presence of any accelerant. Without any firefighting (either active or automatic), the fire took its course and burned every flammable material available. After about 35-40 min, the fire had advanced further along the coach and by 00:00 it had passed midway through the available length. By 00:40, the fire had consumed the entire length of the B2 and had started to self-extinguish, likely having nothing else to burn.

Figure 57. Progression of the fire in the B2 coach (from right to left, in minutes). (Source: EDAPO)

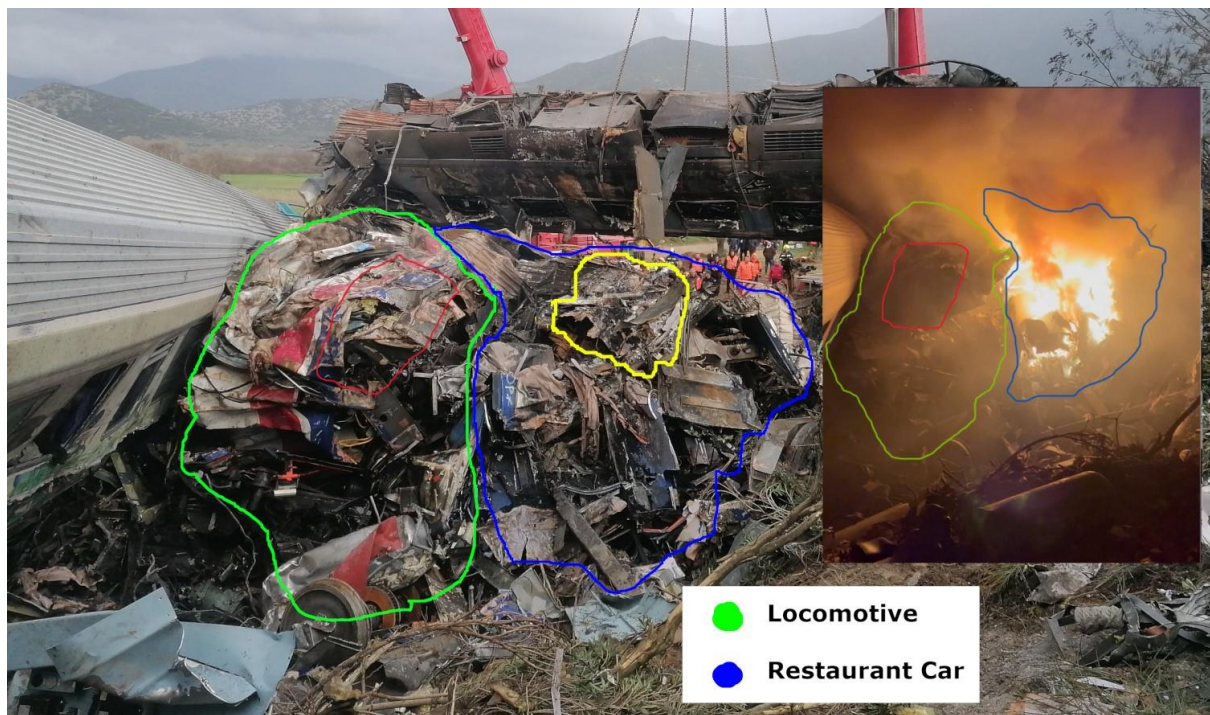
- 462 The passenger videos show a very strong but very concentrated fire burning fiercely from the bottom of the Restaurant Car (color yellow added) while the remains of the passenger train locomotive (including the transformer filled with silicone oil) can be observed at a very close distance but clearly not on fire. This observation can be verified by the examination of the remains of the trains on the next day (Figure 60, Figure 61), where it is clear that the locomotive (color green added) is mechanically destroyed and, like the transformer (color red added), only has burn marks on one side, while the Restaurant Car (color blue added) is totally consumed by the fire.

Figure 60. Restaurant burning next to the passenger train locomotive, with the position of the transformer in red.

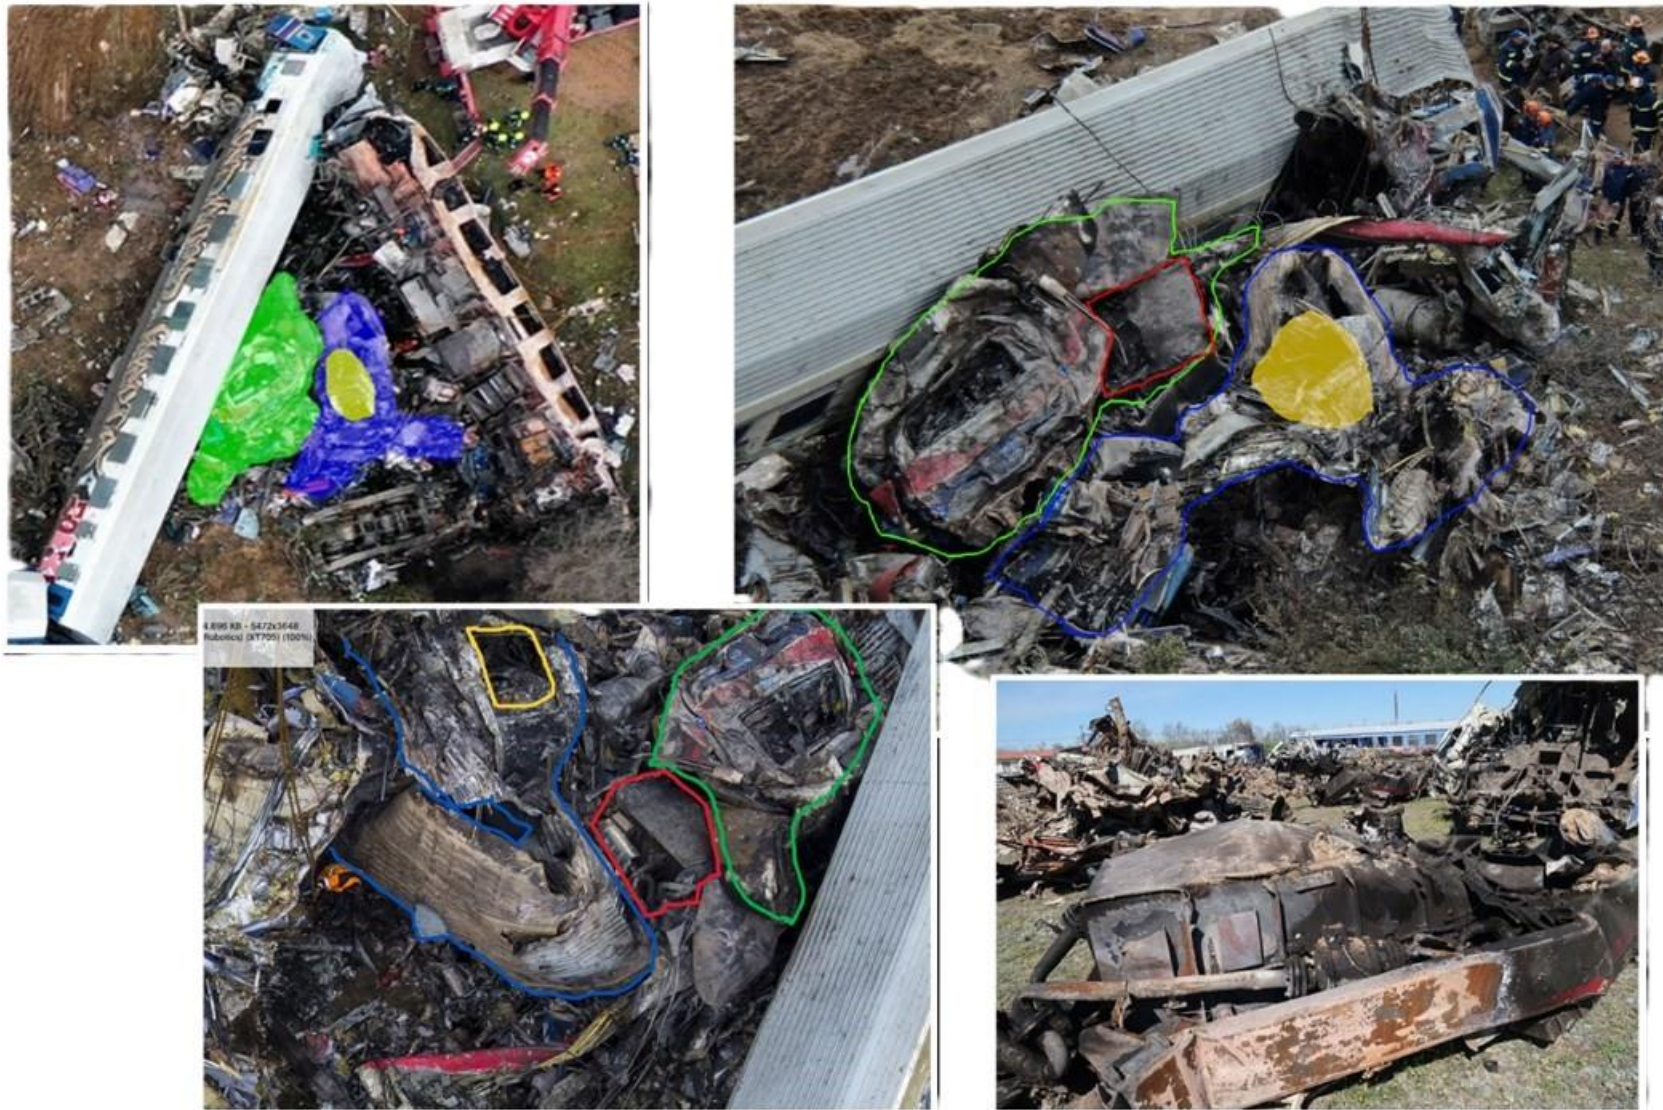
Figure 61. Further images of the location of the Restaurant Car, Passenger Locomotive and its transformer.

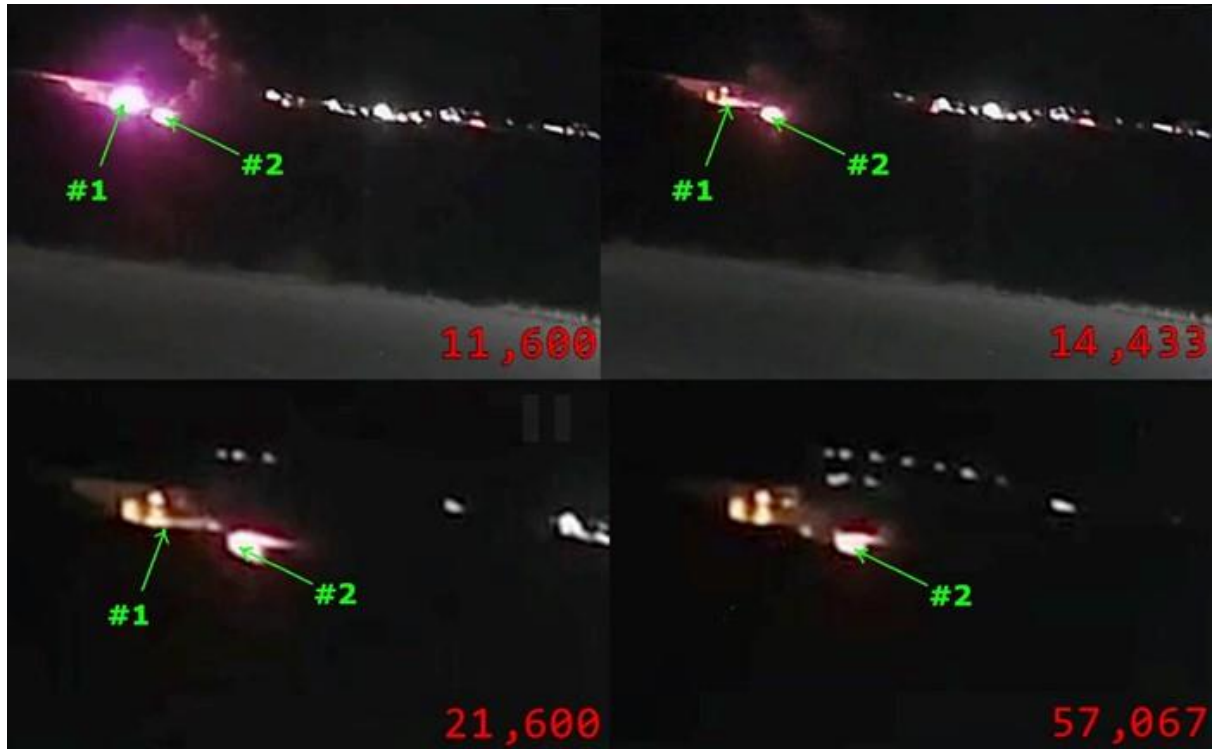
- 463 By following this fire backwards in time, it is most likely that the fire that consumed the Restaurant Car is the same fire that has been recorded 4 minutes after the crash, burning from the bottom of the (crashed and bent in an S-shape) Restaurant Car (color yellow added). This is also the same fire that is observed from the "Maliakos-Kleidi" camera (Fig. Y), as an uninterrupted continuous movement from the fire plume (stage 2) to pool fire #2 (stage 3).

Figure 62. Fire plume moving into pool fire #2, as observed by the "Maliakos-Kleidi" camera.

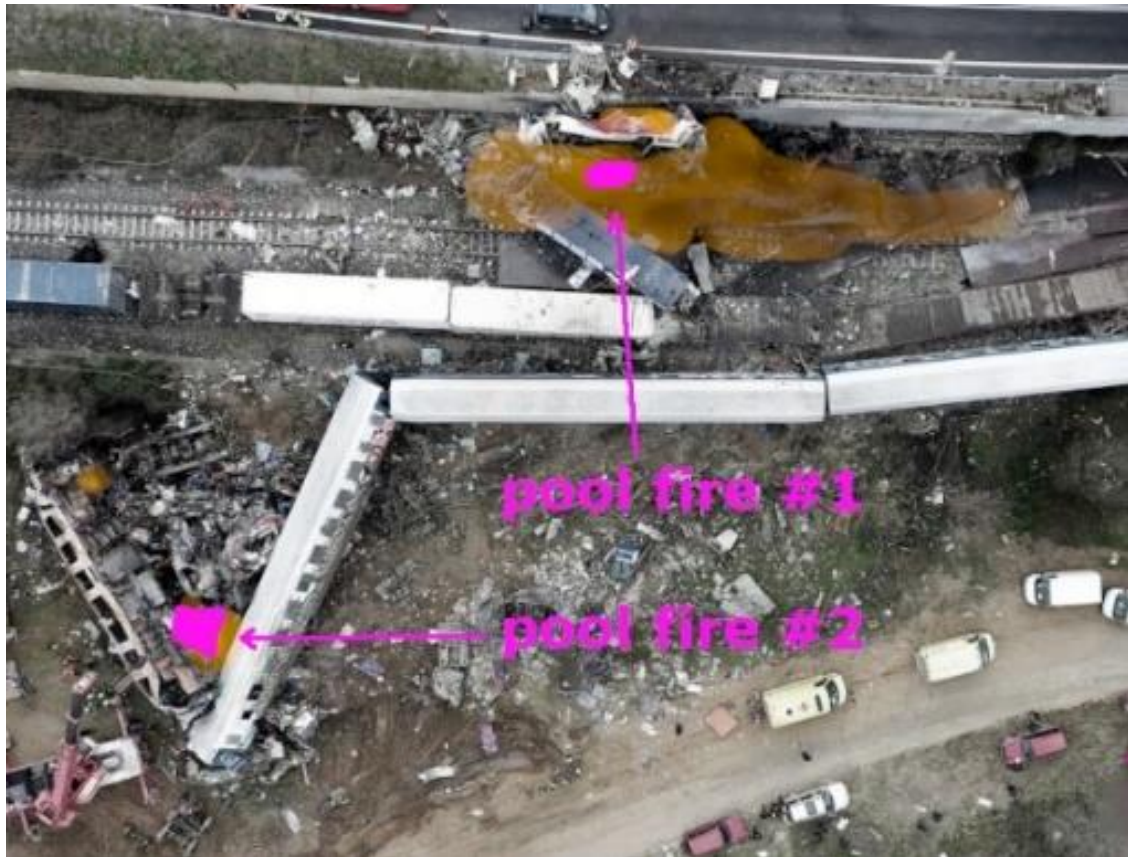
- 464 The two pool fires can be observed burning up any remaining fuel that was not consumed in the fireball. By comparing the geometry of the nighttime frames of video to the daylight images, it is confirmed that the two pool fires are located where fire evidence were found in the morning.

Figure 63. Location and approximate size of pool fires #1 and #2.

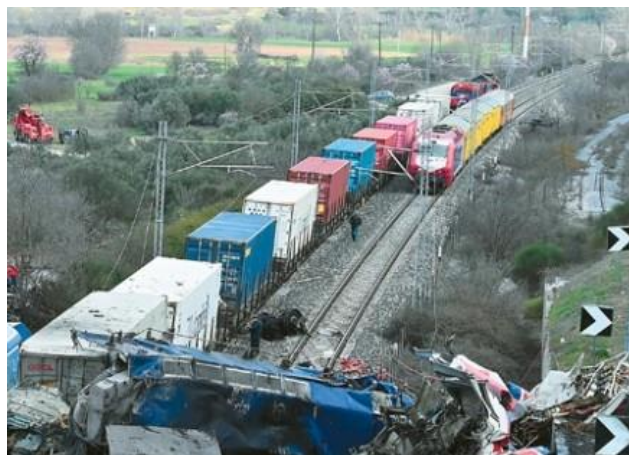
Figure 84. Positions 8)-15) The remaining platforms carrying 8 containers, undamaged and still sealed (or remained empty, of the 2 last ones), not derailed, stopped along the line and were driven away normally.

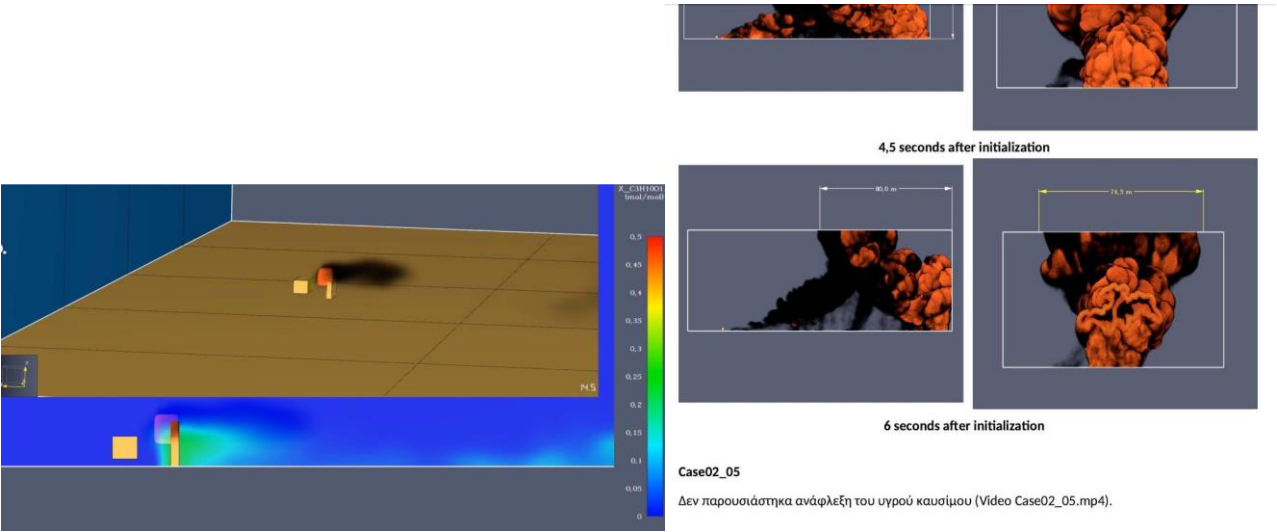
Various tests were run in order to simulate the possibility of silicone oil actually igniting in the presence of a heat source, in the form of an open flame (a pool fire inside a large bucket) or a heated vertical plate. Silicone oil was considered already atomized in small droplets of 500nm (much smaller than the 1000-4000nm as estimated by the RI.SE. report) and the total quantity of fuel was blown in particle form against a heated wall or an open flame. Several simulations were run using different geometries of release and dispersion and different values of AIT (auto-ignition temperature), starting from the realistic value of 450C and going down to 350C as suggested by UGent in order to simulate the possibility of piloted ignition, and even down to 250C which is an unrealistically low value that would be representative of less safe mineral oils.

The results of these tests rule out the possibility of PDMS silicone oils creating such a big fireball and pool fire, as the only possible result is a small localized ignition that will not propagate through the rest of the material, even if the total quantity of silicone oil is unrealistically atomized and dispersed all over the area.

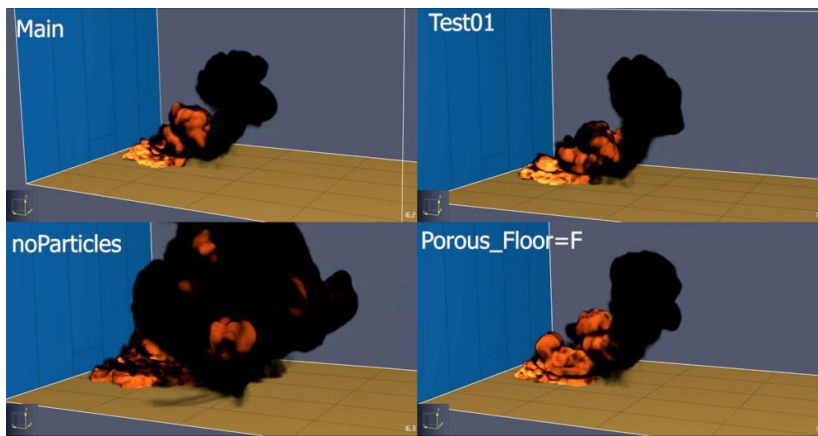
Also, a comparison was run between different amounts of liquid, gas and combined liquid and gas state of the same fuel, in order to validate the sensitivity of the FDS software to changes of state of fuel. Due to lack of any information relevant to volumes of fuel and their headspace, it was decided that no assumption would be made on this issue and the total amount of fuel would be considered as liquid particles.

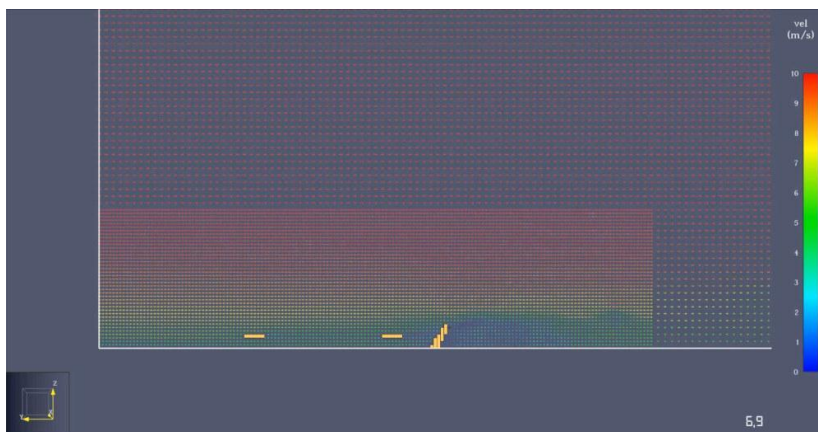
Boundary conditions were also compared in various small scale tests that gave an indication of the effects of the wind profile to the shape of the fireball. It was understood that small changes in the wind profile could affect the shape but not the maximum diameter, the rate of development of the phenomenon or the total duration of the fireball, so a realistic wind profile as close as the meteorological conditions of that day was used with the understanding of the small effect in the end result.

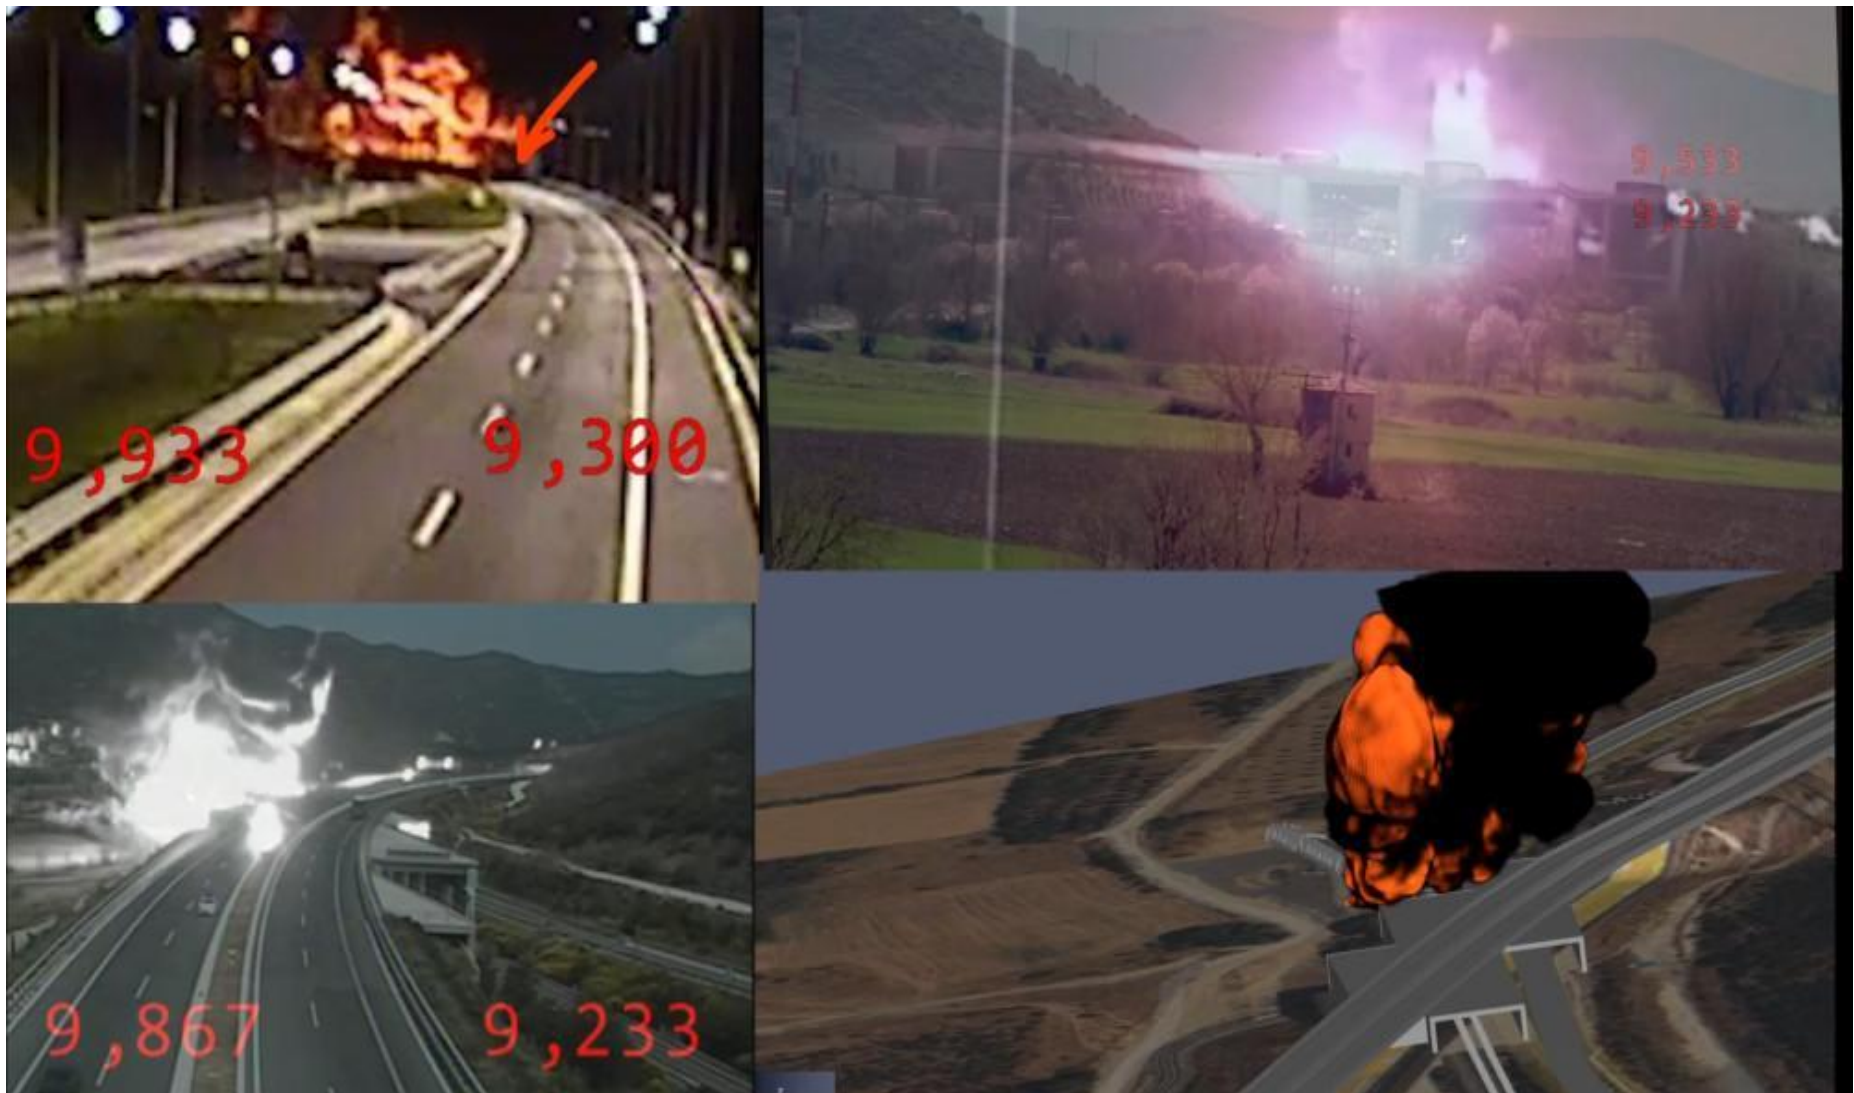
As for the Stage 1 initial release, a comparison of different possible geometries and initial speeds of fuel release showed that the most realistic results were obtained when the fuel particles were blown towards an obstruction with an inclination that would deflect part of the fuel spray upwards and another part to the side. After testing 12 different combinations of fuel quantities and fuel speeds for the two releases, the one most closely resembling the recorded video was Case08\_07 with respective quantities of 800 kg for stage 1, 1200 kg for Stage 2 and 300-500kg for stage 3 pool fire. Obviously, this is only to provide an order of magnitude and not an exact number, as there are other combinations of fuel, velocities and geometries that could possibly replicate the target video. It is clear, though, that the order of magnitude is correct, as it is not possible to create a comparable sized fireball without at least 2000kg of fuel. Furthermore, absence of a large pool fire #1 as recorded by video evidence, rules out the possibility of a larger quantity of fuel (e.g. 10-15tn) that would have created and sustained a large pool fire as an aftermath to the crash.
